ARBORIST TREE ASSESSMENT REPORT

**STATE ROUTE 23
DRAINAGE RESTORATION PROJECT
VENTURA COUNTY, CALIFORNIA**

LSA Project No. GPA2202.01

July 2022

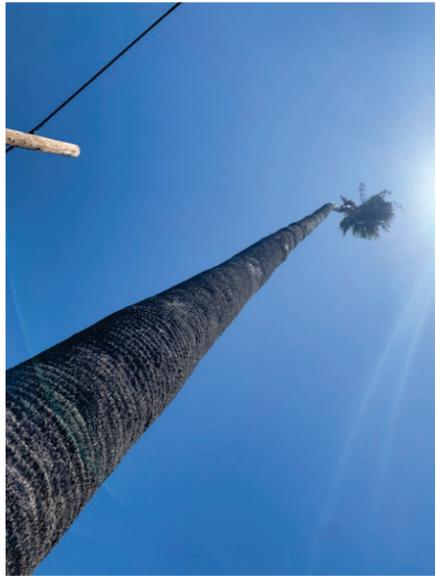
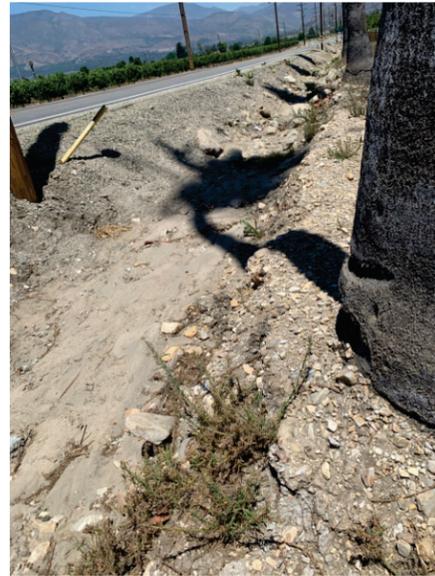
Tree 1 – Mexican fan palm in fair condition, adjacent to roadside ditch, provide root protection.

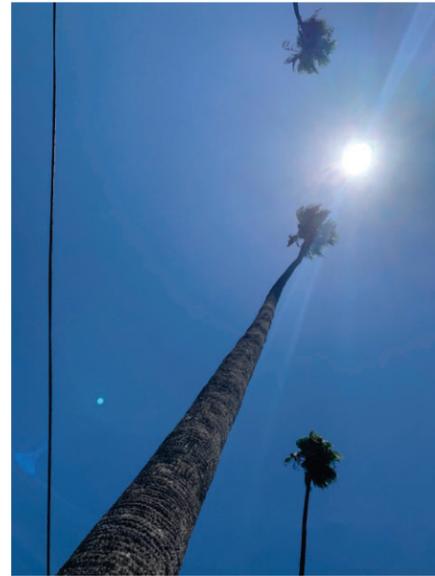
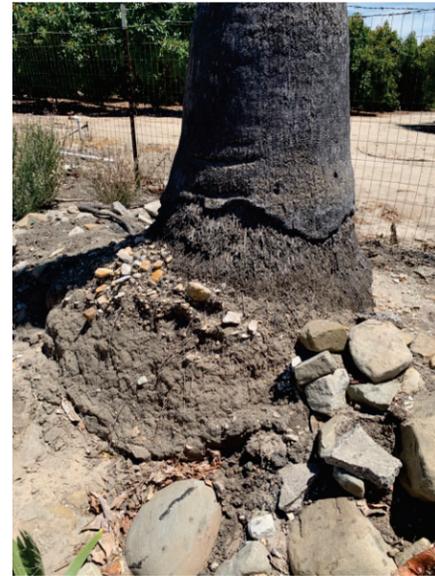
Tree 2 – Mexican fan palm in poor condition, palm tree stability compromised by roadside ditch erosion.

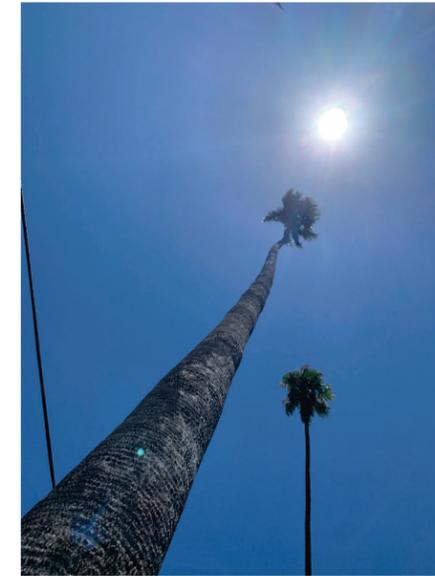
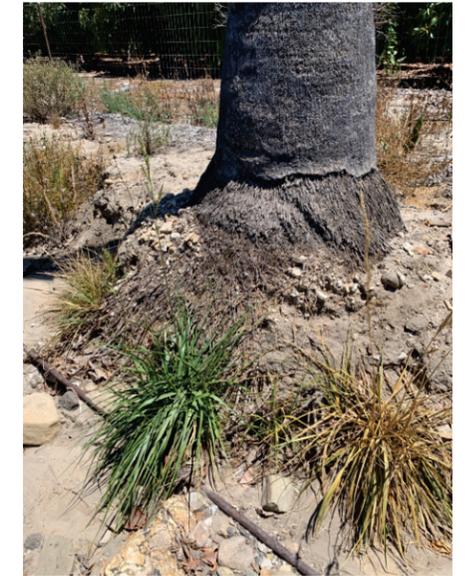
Tree 3 – Mexican fan palm in poor condition, palm tree stability compromised with exposed root ball by roadside ditch erosion.

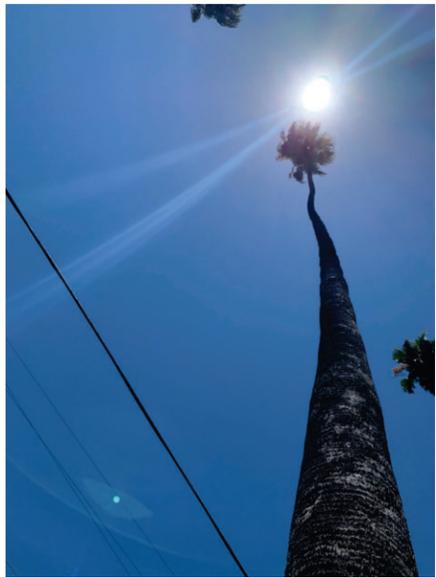
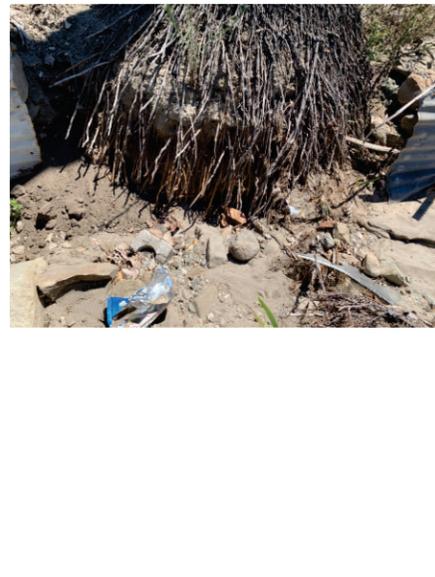
Tree 4 – Mexican fan palm in poor condition, palm tree stability extremely compromised with undercutting of exposed root ball by roadside ditch erosion.

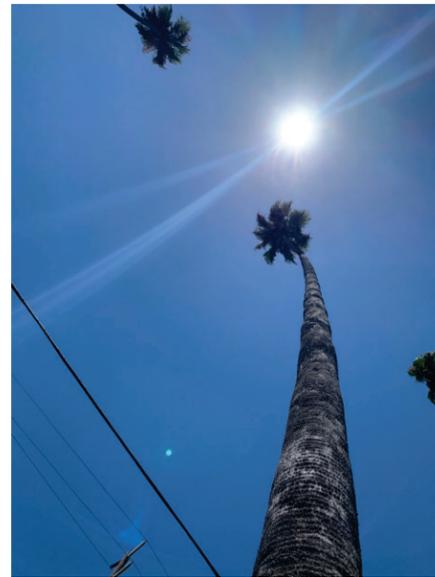
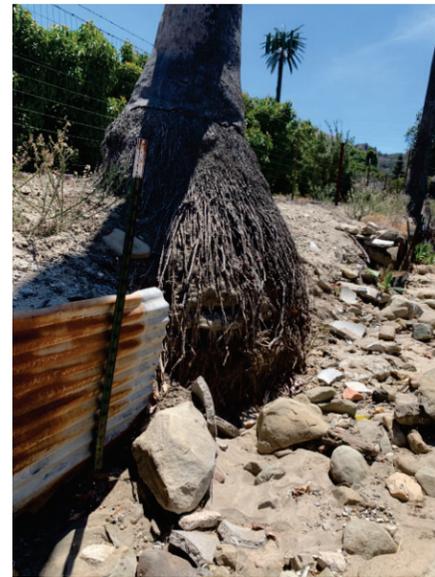
Tree 5 – Mexican fan palm in poor condition, palm tree stability extremely compromised with undercutting of exposed root ball by roadside ditch erosion.

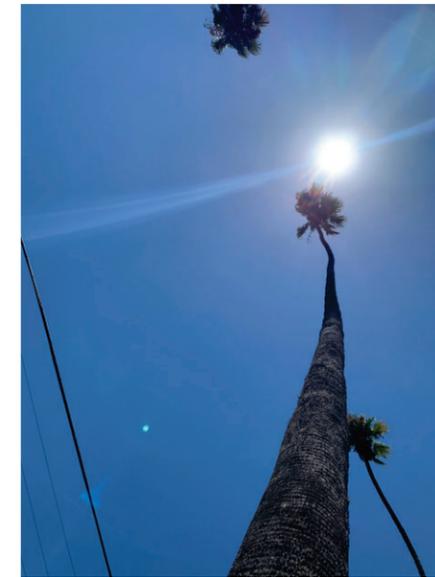
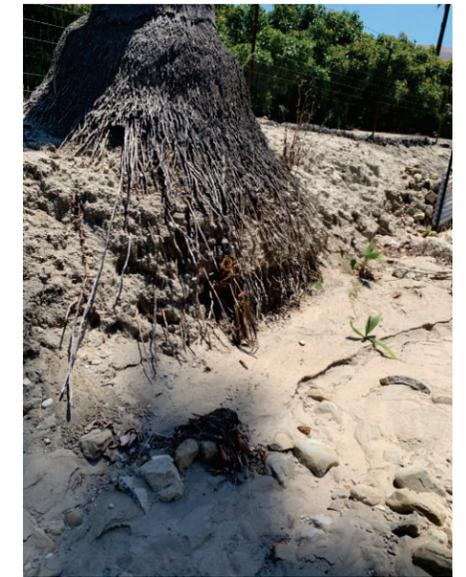
Tree 6 – Mexican fan palm in poor condition, palm tree stability extremely compromised with undercutting of exposed root ball by roadside ditch erosion.

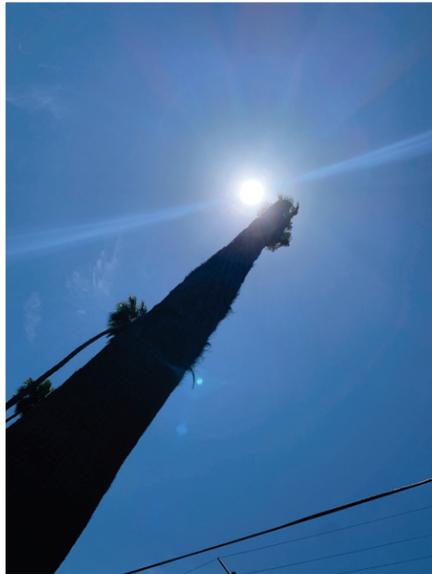
Tree 7 – Mexican fan palm in fair condition, palm tree stability may be compromised by roadside ditch erosion.

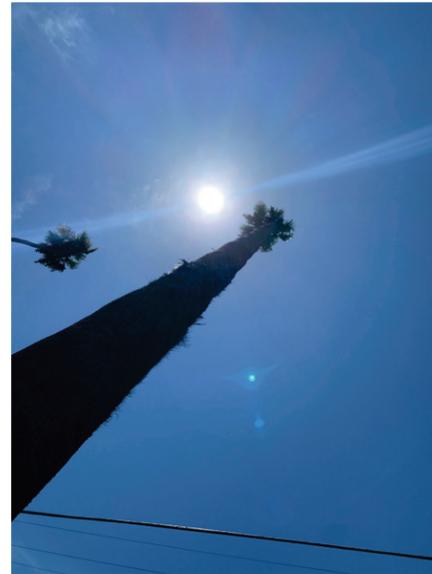
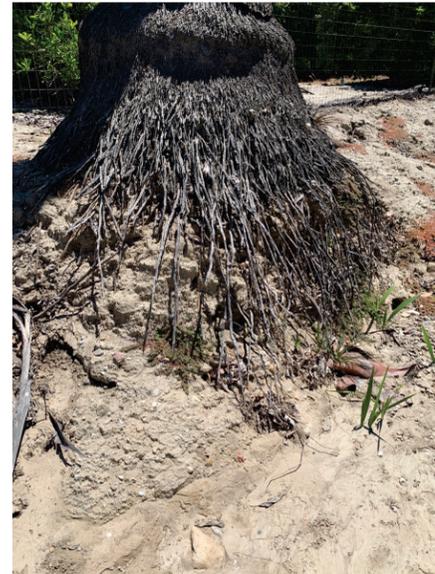
Tree 8 – Mexican fan palm in poor condition, palm tree stability extremely compromised with undercutting of exposed root ball by roadside ditch erosion.

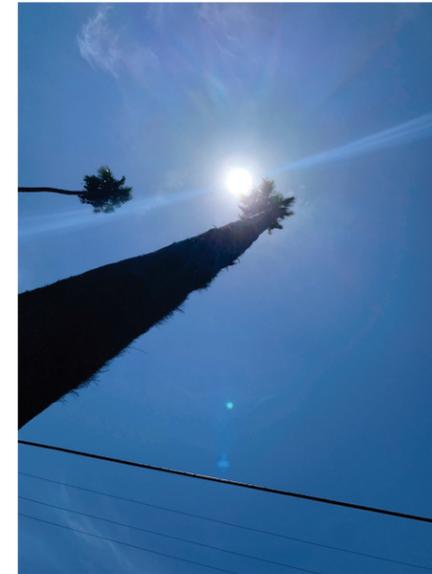
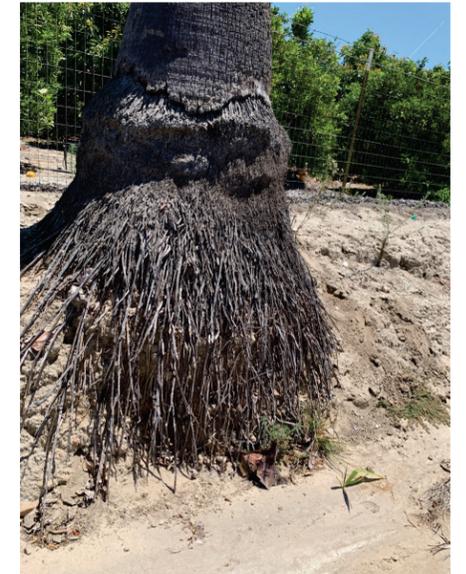
Tree 9 – Mexican fan palm in poor condition, palm tree stability extremely compromised with undercutting of exposed root ball by roadside ditch erosion.

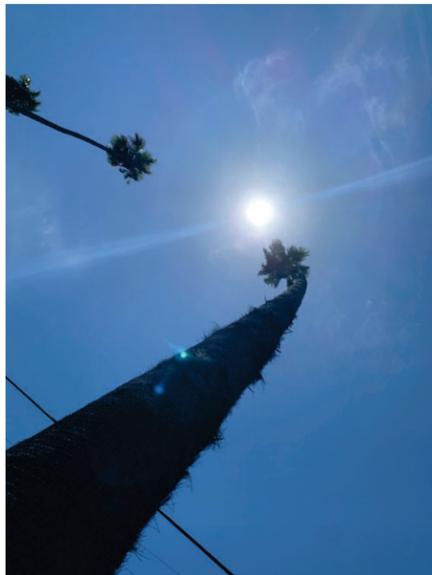
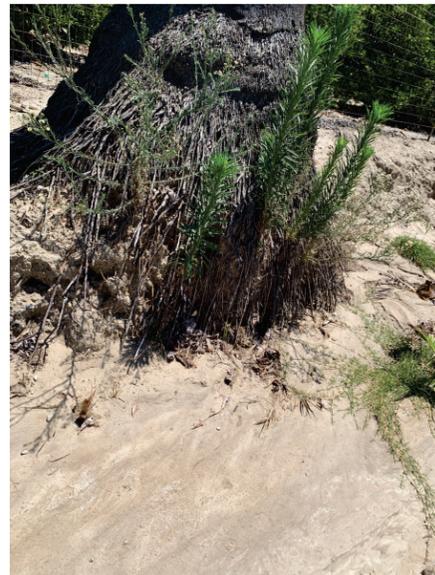
Tree 10 – Mexican fan palm in poor condition, palm tree stability extremely compromised with undercutting of exposed root ball by roadside ditch erosion.

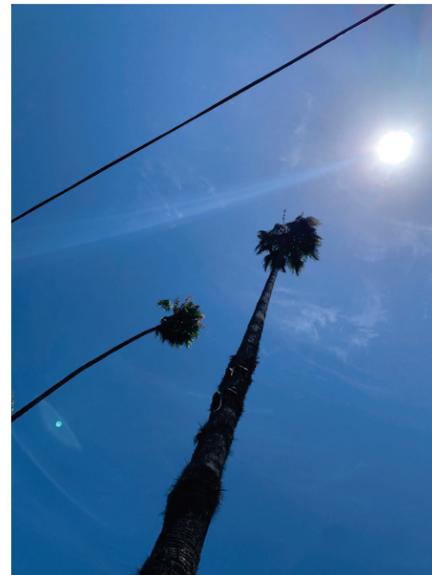
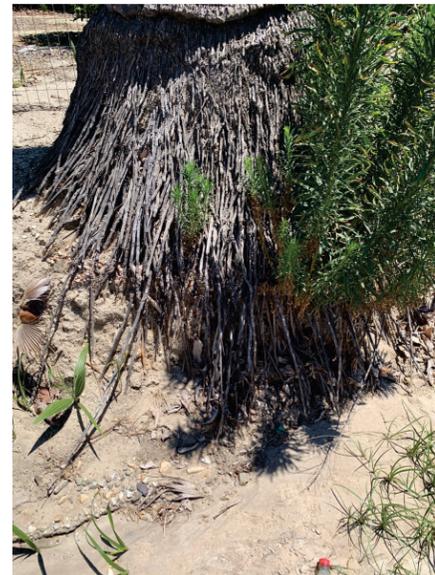
Tree 11 – Mexican fan palm in poor condition, palm tree stability extremely compromised with undercutting of exposed root ball by roadside ditch erosion.

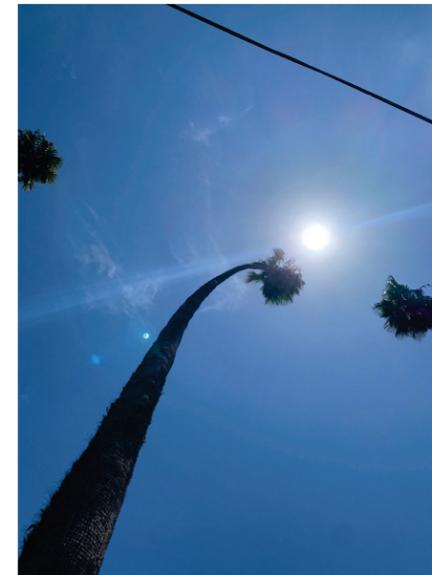
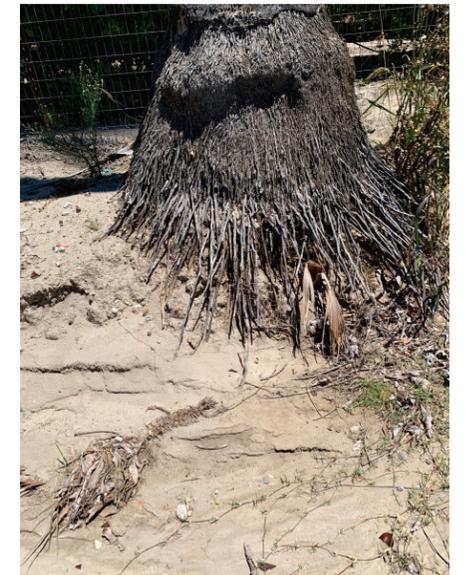
Tree 12 – Mexican fan palm in poor condition, palm tree stability extremely compromised with undercutting of exposed root ball by roadside ditch erosion.

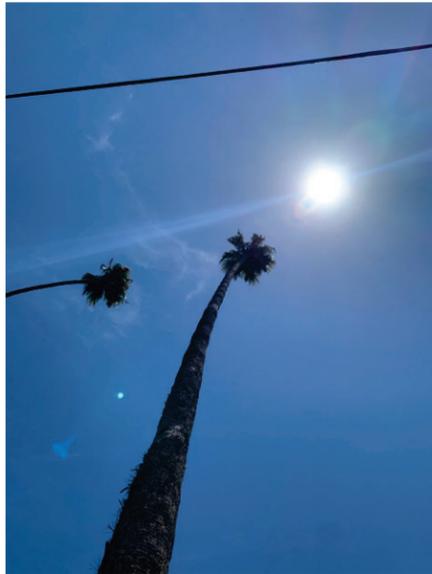
Tree 13 – Mexican fan palm in poor condition, palm tree stability compromised by roadside ditch erosion.

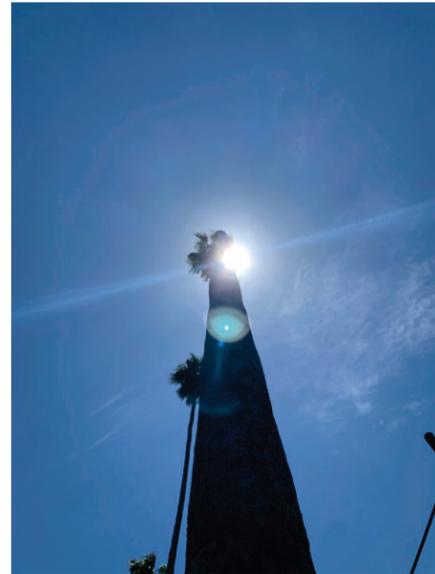
Tree 14 – Mexican fan palm in fair condition, adjacent to roadside ditch, provide root protection.

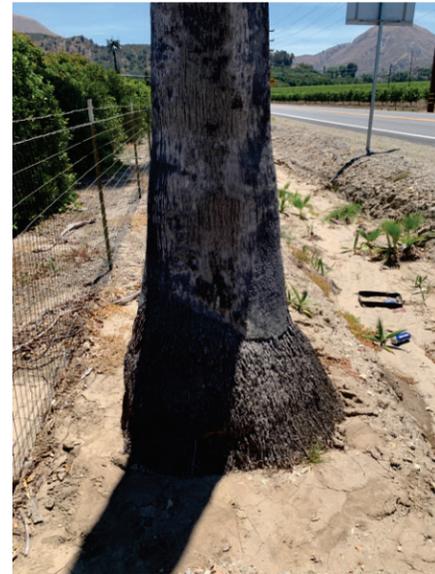
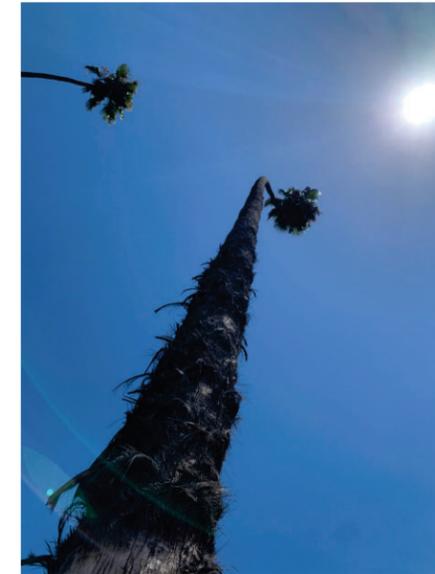
Tree 15 – Mexican fan palm in fair condition, not compromised by roadside ditch erosion.

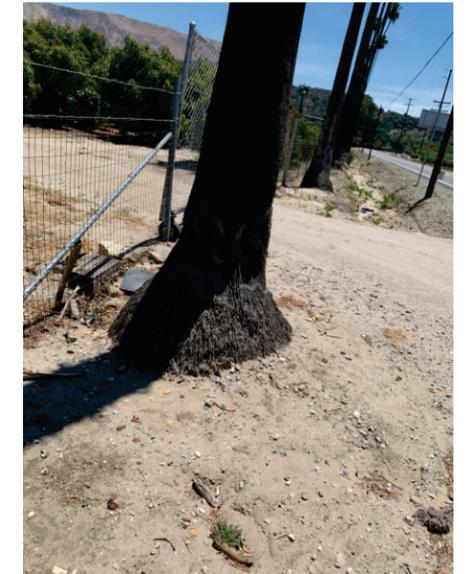
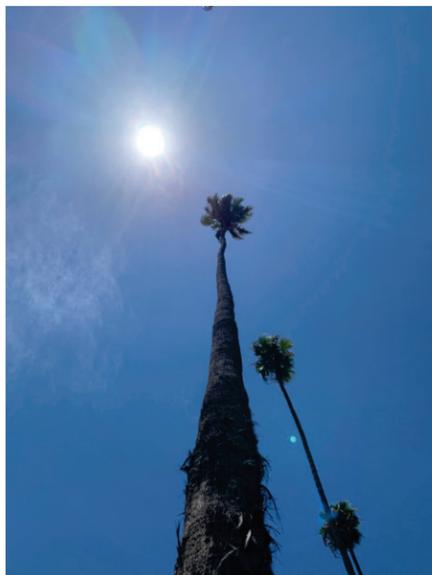
Tree 16 – Mexican fan palm in poor condition, palm tree stability compromised by roadside ditch erosion.

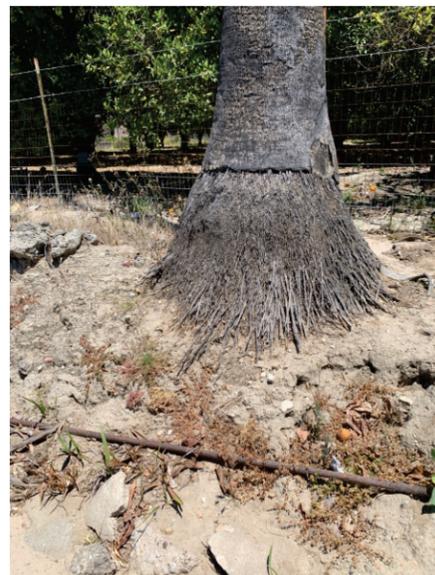
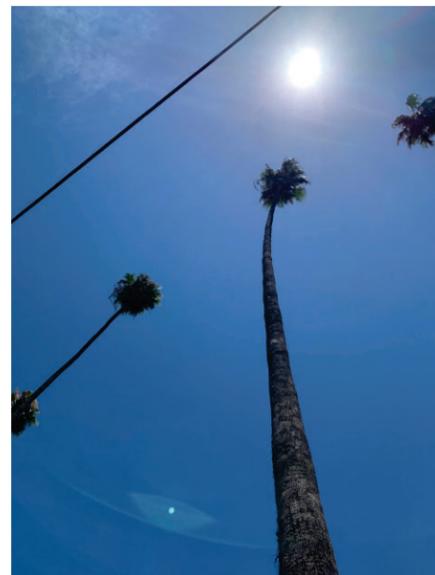
Tree 17 – Mexican fan palm in poor condition, palm tree stability compromised by roadside ditch erosion.

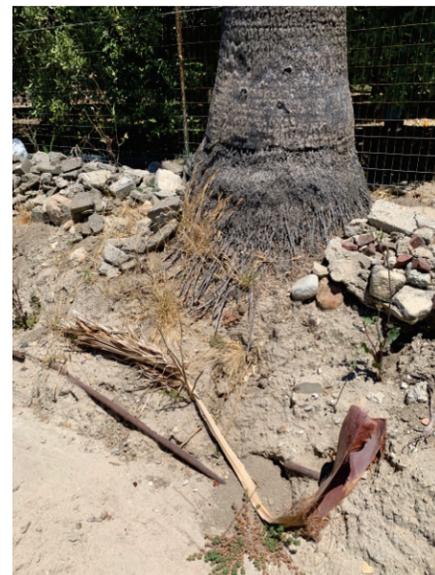
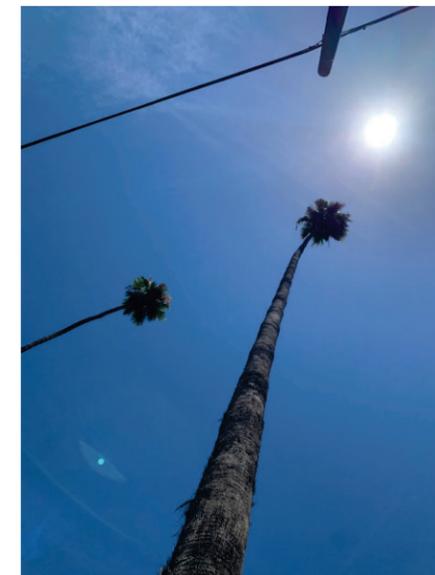
Tree 18 – Mexican fan palm in poor condition, palm tree stability compromised with exposed root ball by roadside ditch erosion.

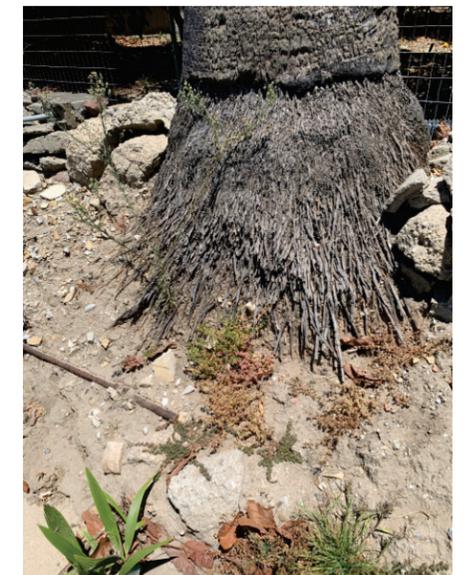
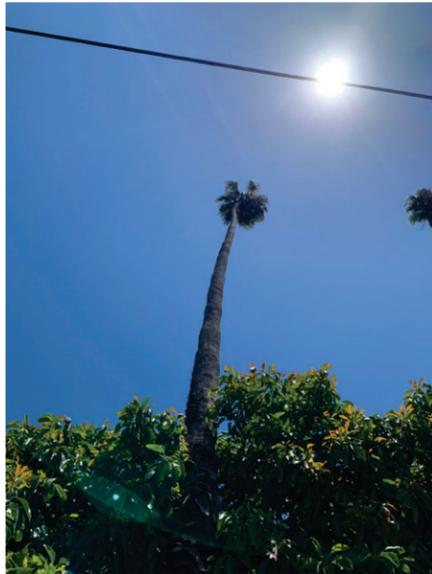
Tree 19 – Mexican fan palm in fair condition, not compromised by roadside ditch erosion.

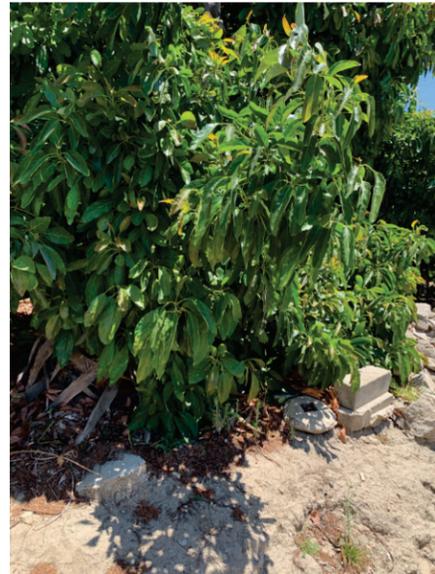
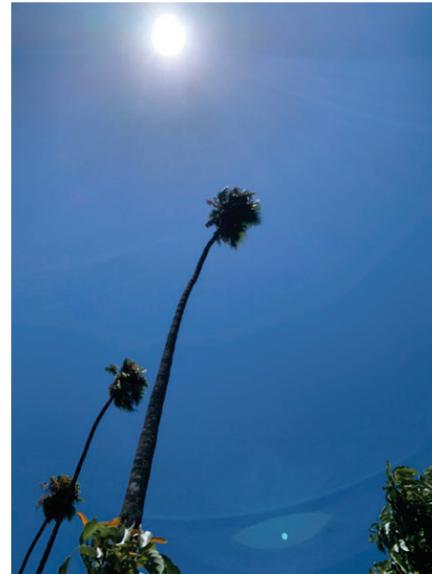
Tree 20 – Mexican fan palm in fair condition, not compromised by roadside ditch erosion.

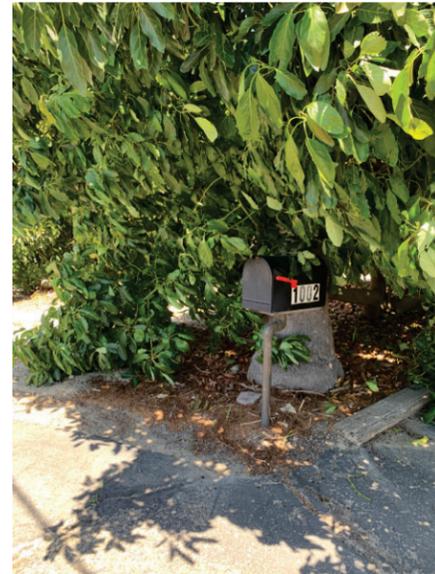
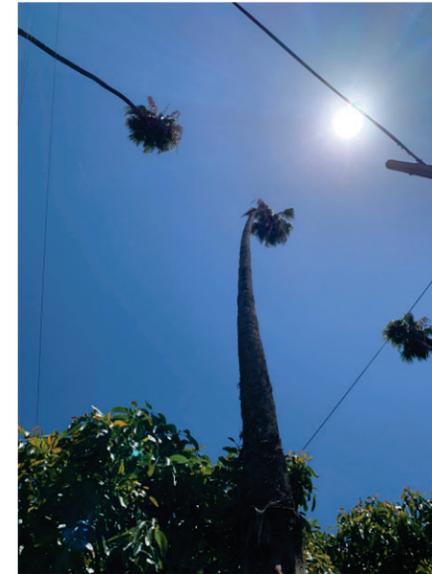
Tree 21 – Mexican fan palm in poor condition, palm tree stability compromised with exposed root ball by roadside ditch erosion.

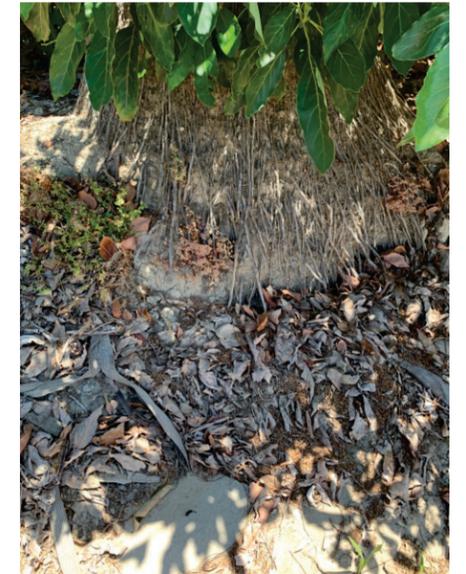
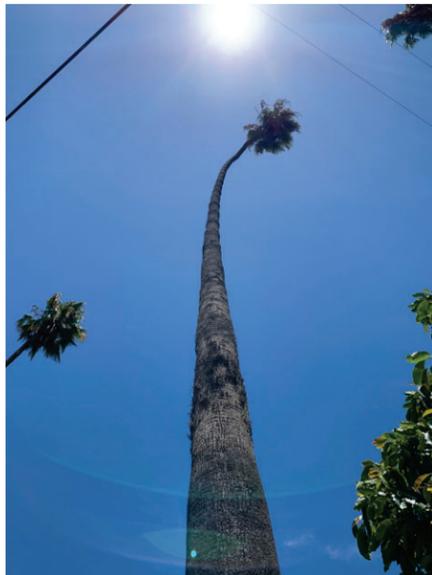
Tree 22 – Mexican fan palm in poor condition, palm tree stability extremely compromised with undercutting of exposed root ball by roadside ditch erosion.

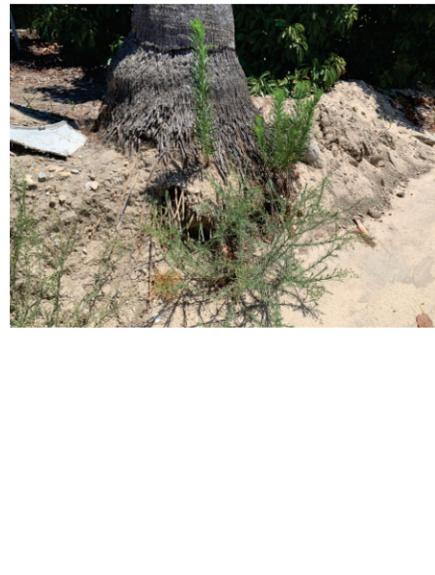
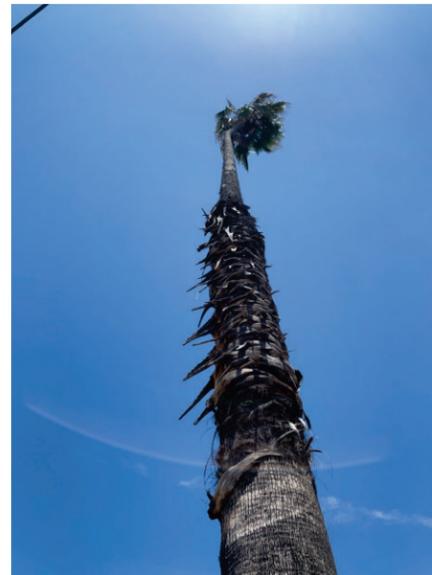
Tree 23 – Mexican fan palm in poor condition, palm tree stability compromised with exposed root ball by roadside ditch erosion.

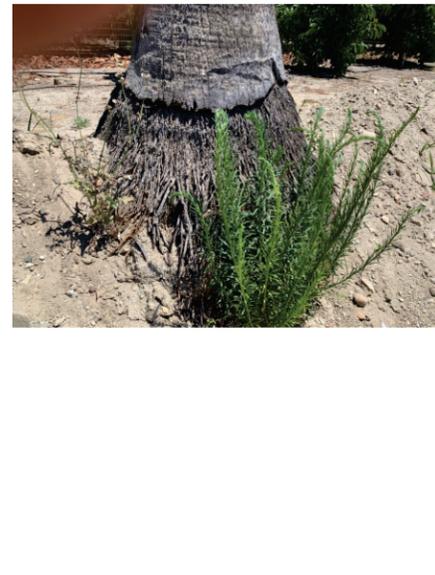
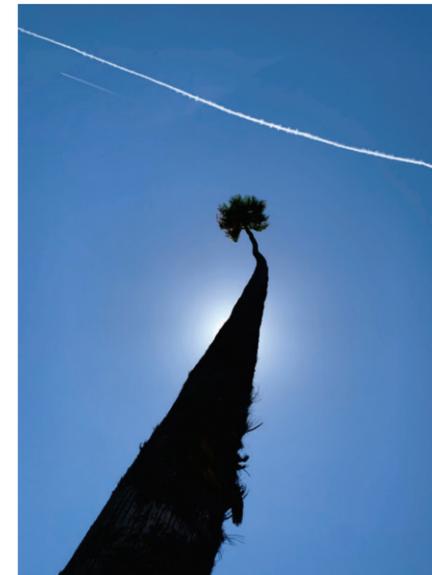
Tree 24 – Mexican fan palm in poor condition, palm tree stability compromised by roadside ditch erosion.

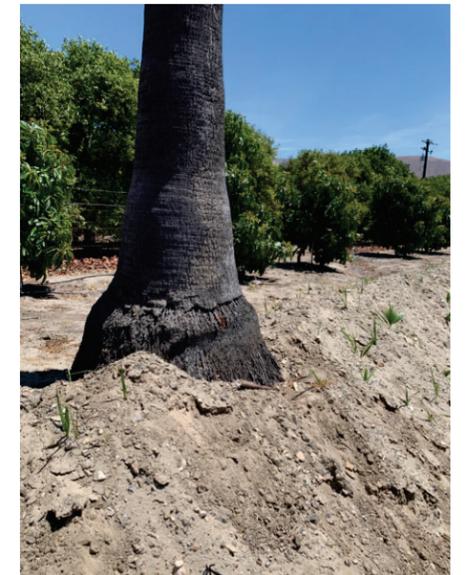
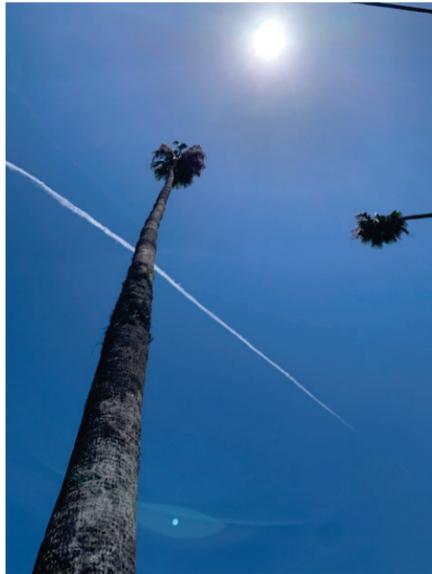
Tree 25 – Mexican fan palm in poor condition, palm tree stability compromised with exposed root ball by roadside ditch erosion.

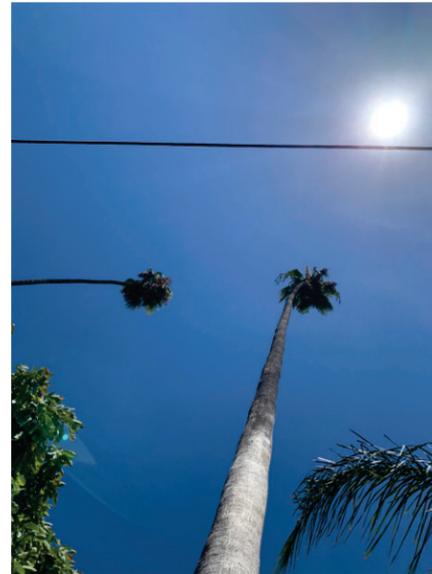
Tree 26 – Mexican fan palm in poor condition, palm tree stability extremely compromised with undercutting of exposed root ball by roadside ditch erosion.

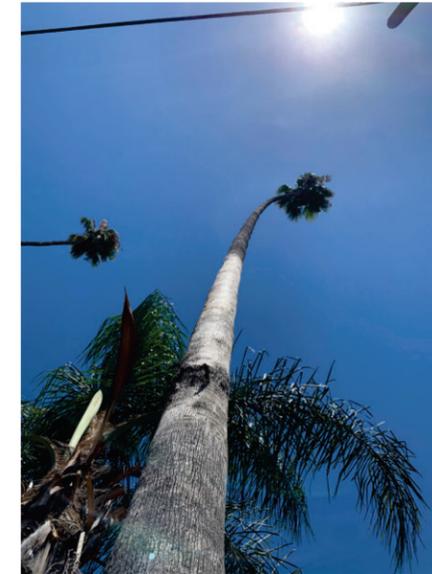
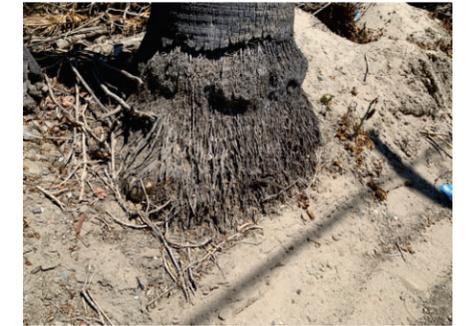
Tree 27 – Mexican fan palm in poor condition, palm tree stability extremely compromised with undercutting of exposed root ball by roadside ditch erosion.

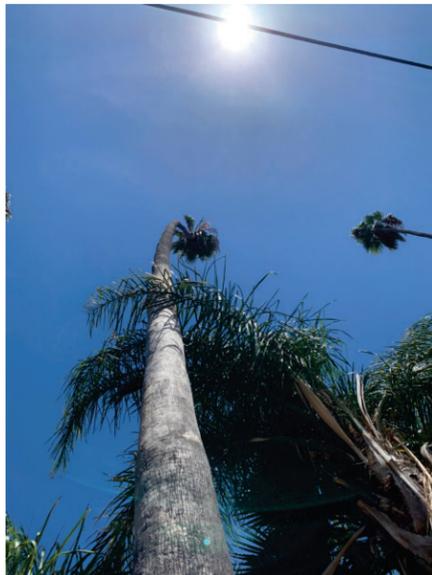
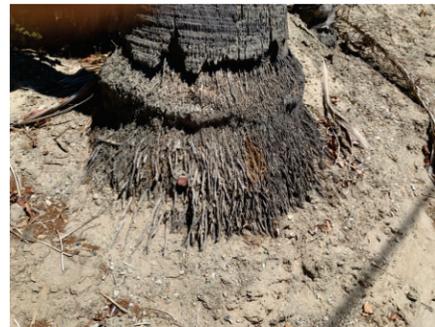
Tree 28 – Mexican fan palm in poor condition, palm tree stability compromised with exposed root ball by roadside ditch erosion.

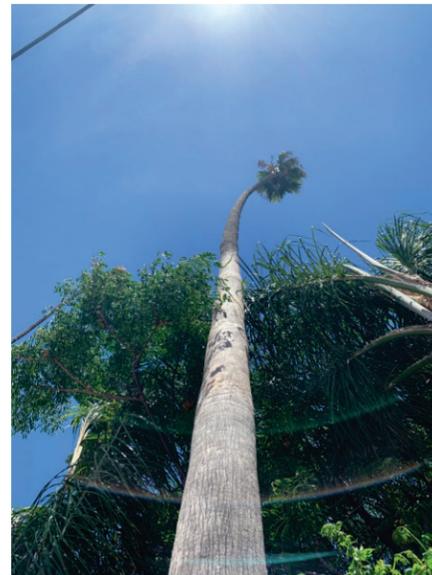
Tree 29 – Mexican fan palm in poor condition, palm tree stability compromised with exposed root ball by roadside ditch erosion.

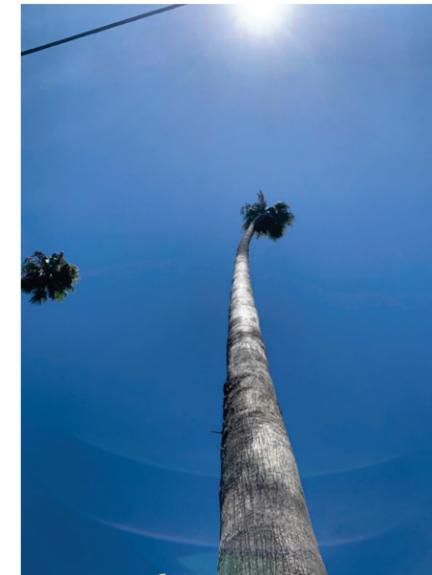
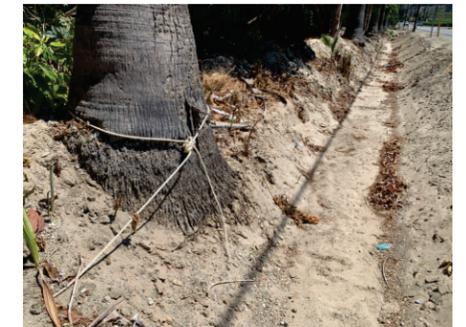
Tree 30 – Mexican fan palm in poor condition, palm tree stability compromised with exposed root ball by roadside ditch erosion.

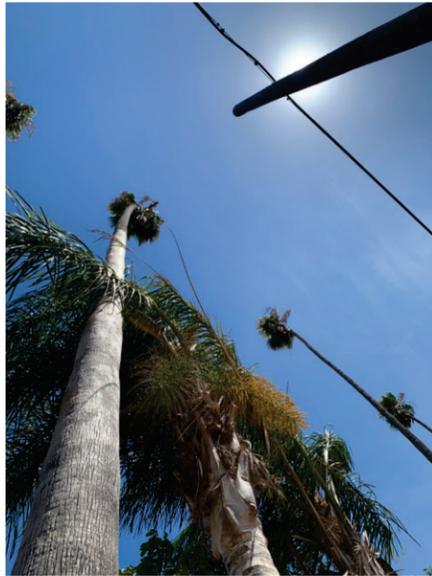
Tree 31 – Mexican fan palm in fair condition, palm tree stability compromised by roadside ditch erosion.

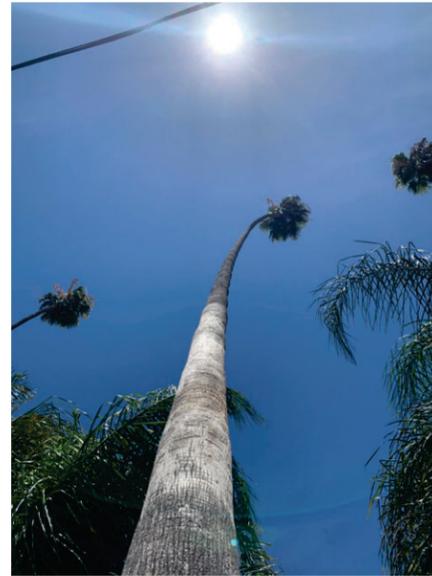
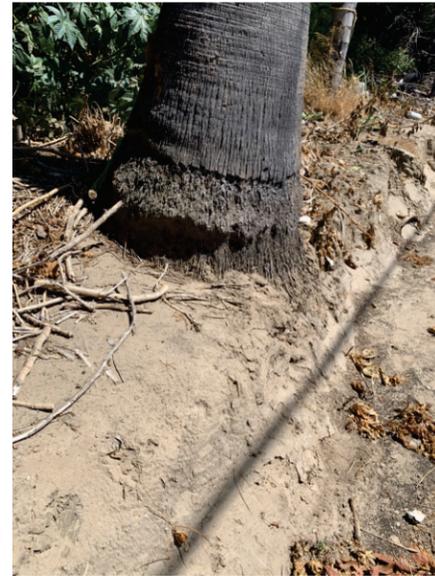
Tree 32 – Mexican fan palm in fair condition, palm tree stability compromised by roadside ditch erosion.

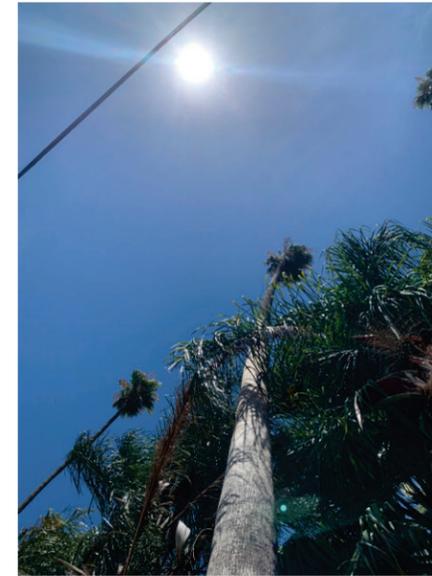
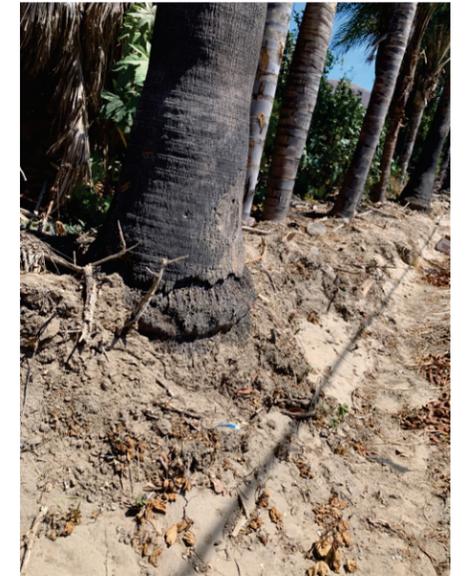
Tree 33 – Mexican fan palm in poor condition, palm tree stability compromised by roadside ditch erosion.

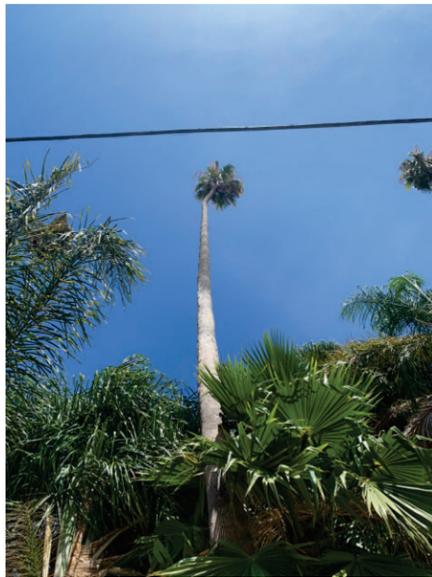
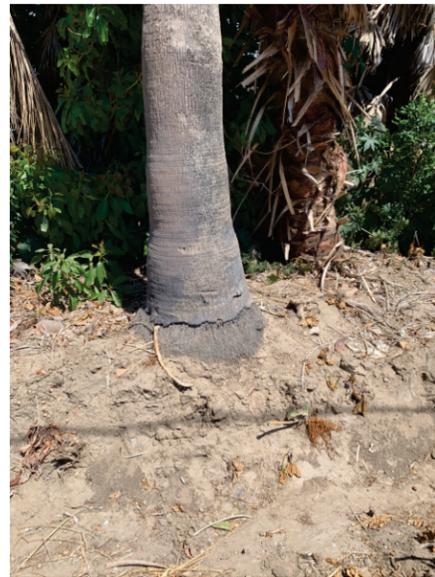
Tree 34 – Mexican fan palm in fair condition, palm tree stability compromised by roadside ditch erosion.

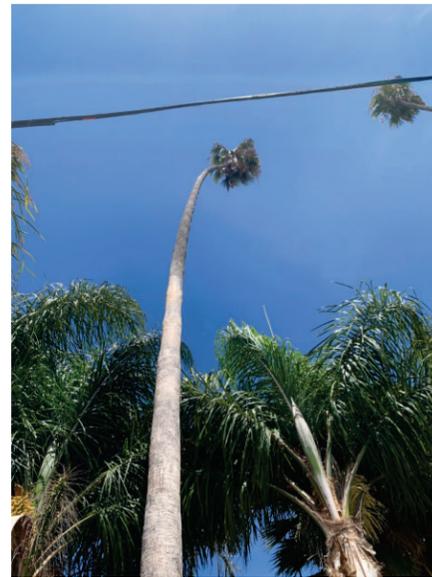
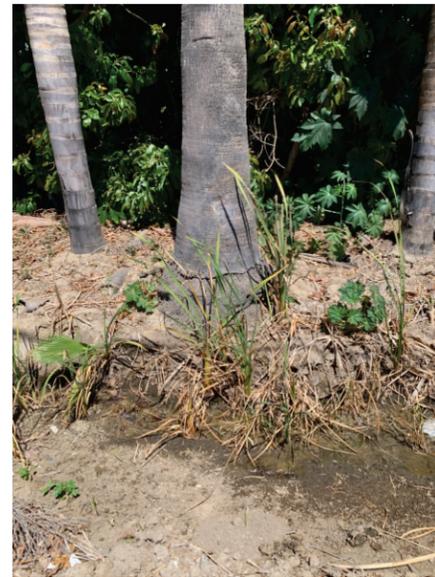
Tree 35 – Mexican fan palm in fair condition, palm tree stability compromised by roadside ditch erosion.

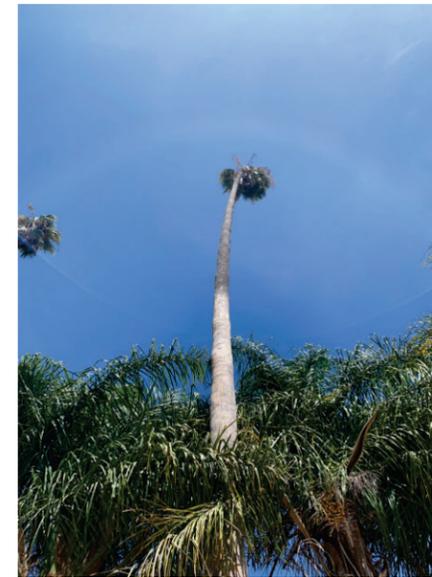
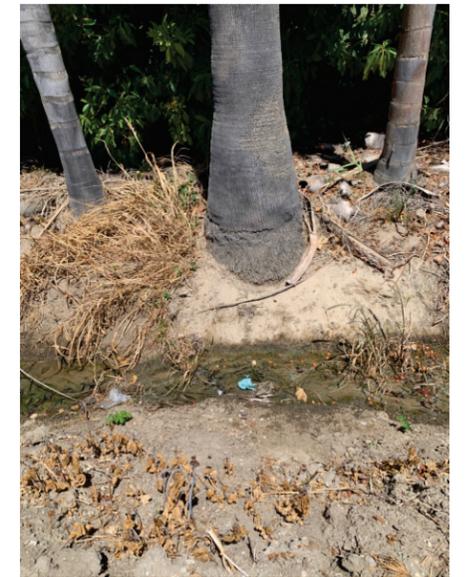
Tree 36 – Mexican fan palm in fair condition, palm tree stability compromised by roadside ditch erosion.

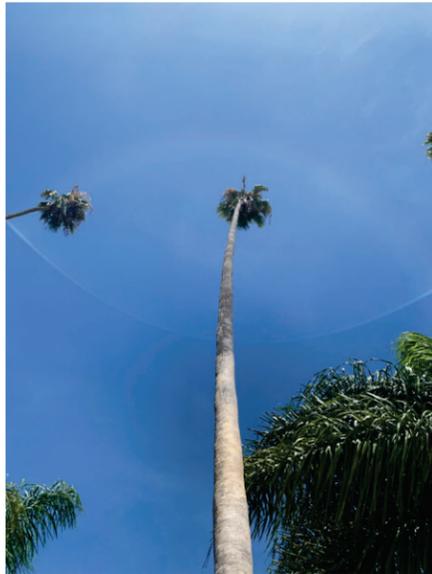
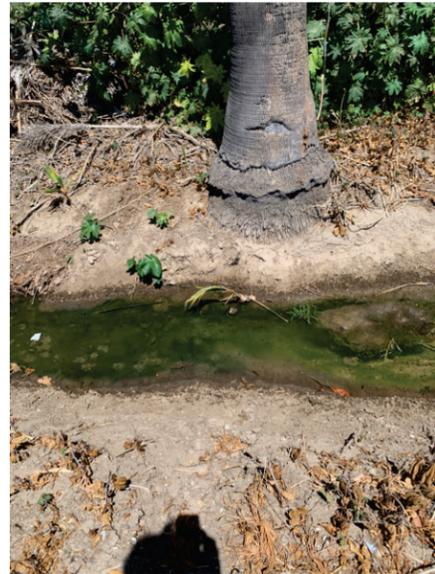
Tree 37 – Mexican fan palm in fair condition, palm tree stability compromised by roadside ditch erosion.

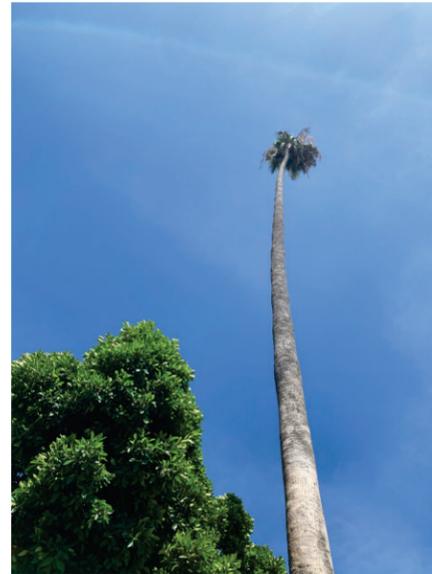
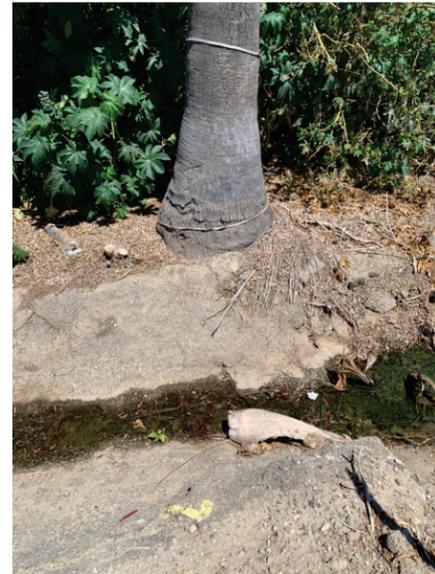
Tree 38 – Mexican fan palm in fair condition, palm tree stability compromised by roadside ditch erosion.
