**To:** Dillan Murray, Assistant Planner, County of Ventura Resource Management Agency  
**via:** Mark Ross, Kevin Sheppard, Ashley James  
**From:** Mitch Stone, San Buenaventura Research Associates  
**Date:** 20 May 2022  
**Re:** Ojai Arts (2464 E. Ojai Avenue) Rehabilitation Plan Addendum

## Ojai Arts (2464 E. Ojai Avenue) Rehabilitation Plan

**Cultural Heritage: Application for Certificate of Review  
Fenestration Patterns**

**2022 - 0519**

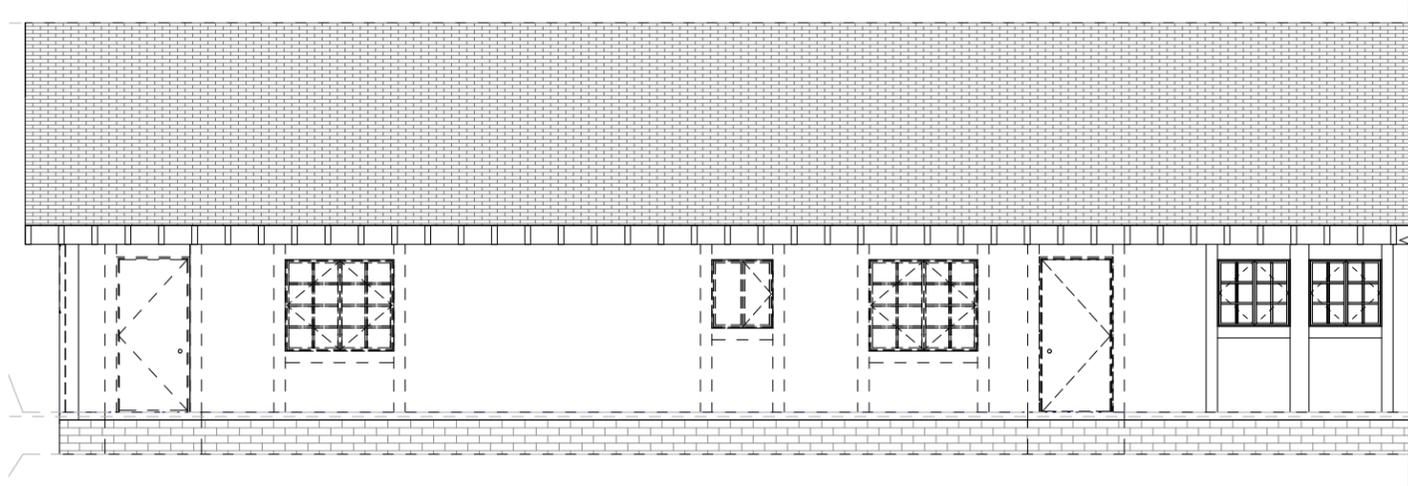
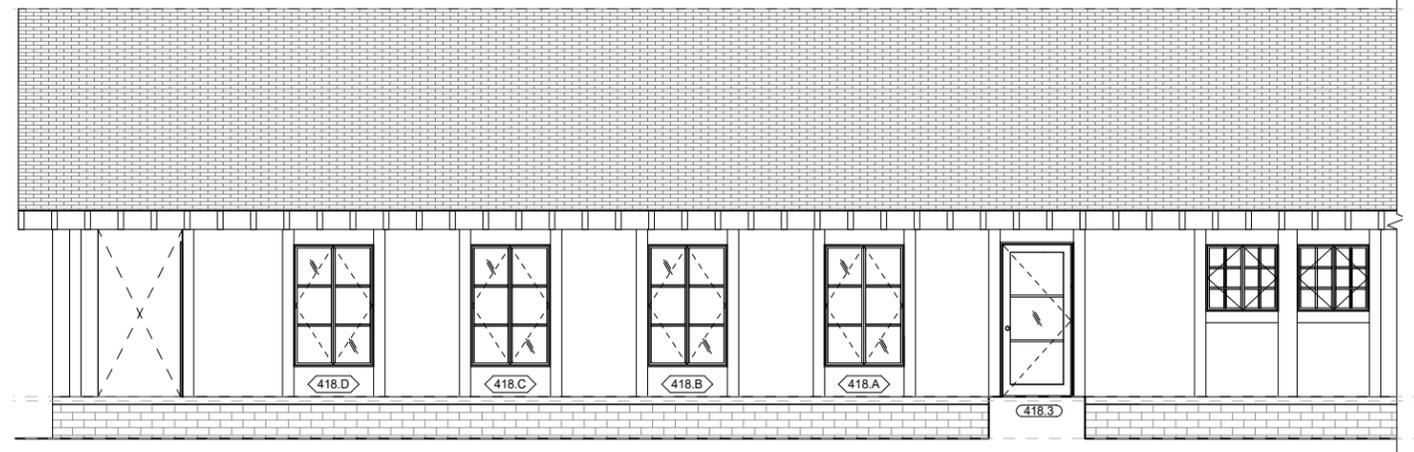
WEST - 2021 CONDITION DEMO

WEST - PROPOSED ELEVATION. OPENINGS TO COORDINATE WITH LOCATION OF DOOR AND WINDOW ROUGH OPENINGS REVEALED IN EXPOSED FRAMING

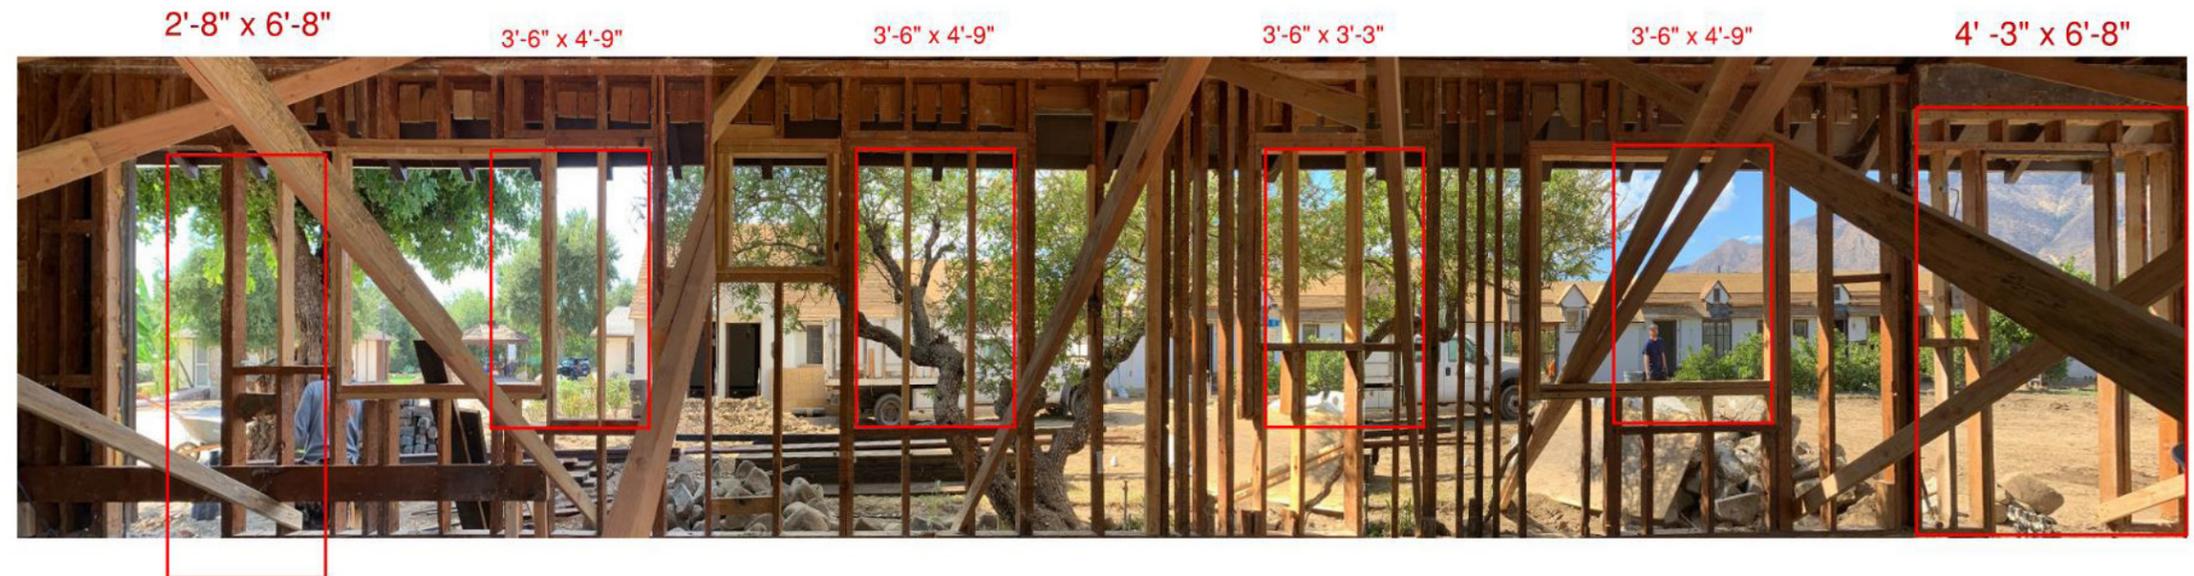
FRAMING LOCATION OF DOOR AND WINDOW ROUGH OPENINGS REVEALED IN EXPOSED FRAMING

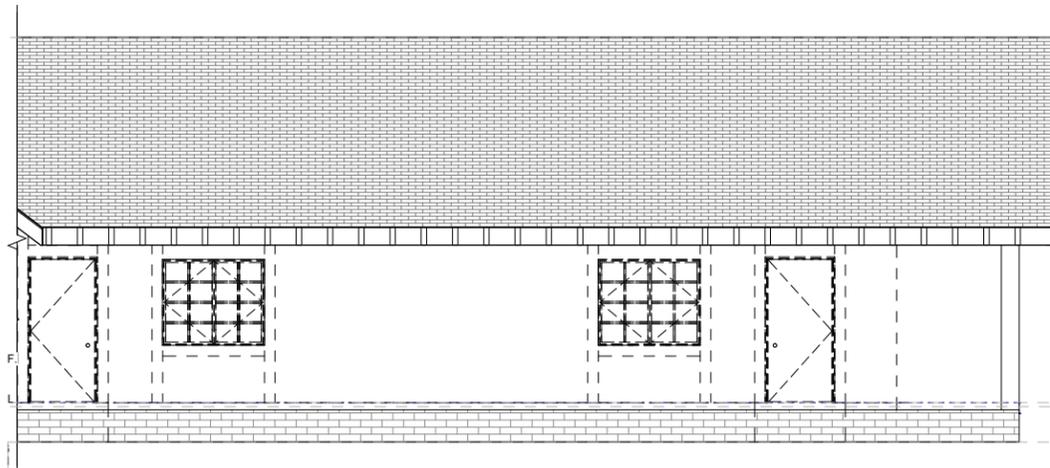
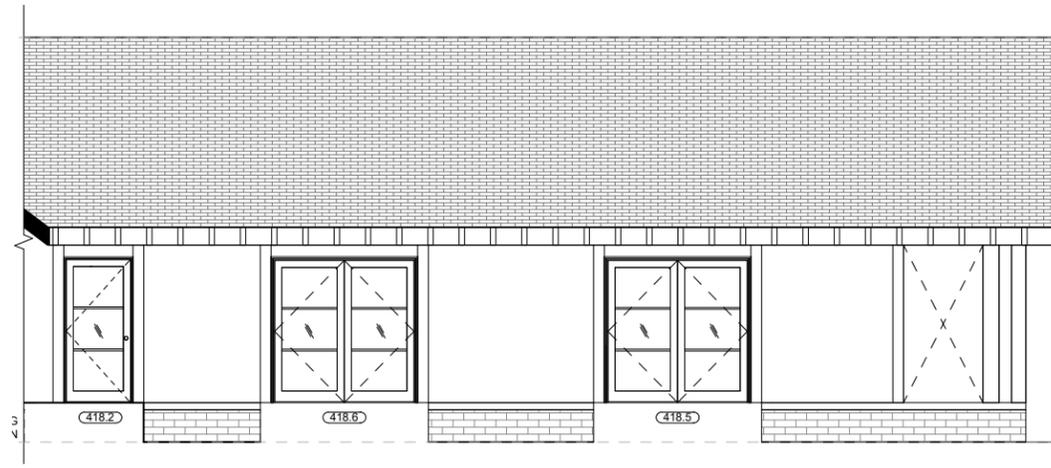
EAST - 2021 CONDITION DEMO

EAST - PROPOSED ELEVATION. RELOCATED AND EXPANDED OPENINGS FOR IMPROVED CIRCULATION AND VENTILATION. EXPOSED FRAMING DOES NOT APPEAR ORIGINAL AND DID NOT REVEAL ANY CLEAR INDICATION OF ORIGINAL OPENINGS

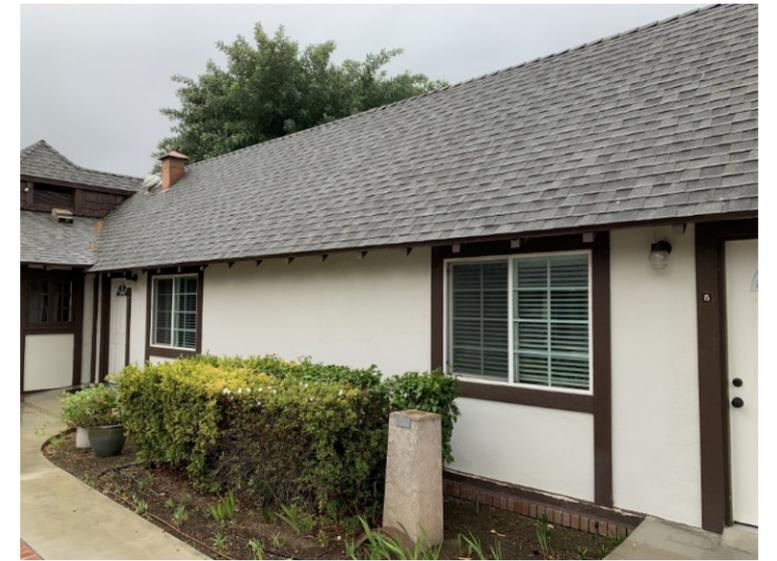
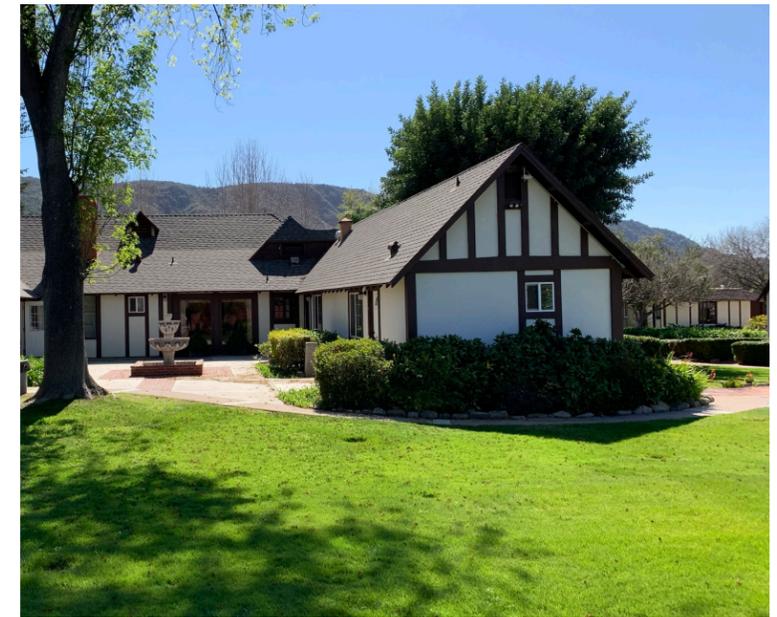
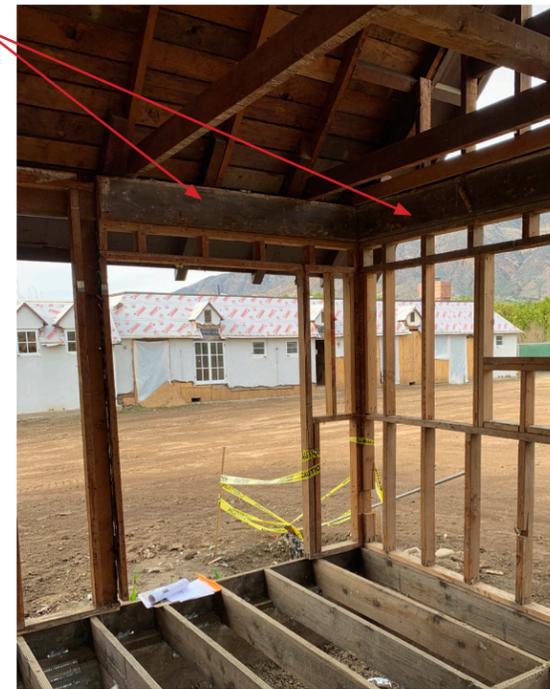
DOOR AND WINDOW UNITS SHOWN IN 2021 CONDITION PHOTOS WERE NONHISTORIC FIBERGLASS AND ALUMINUM UNITS.

EXPOSED HEADER CONDITION

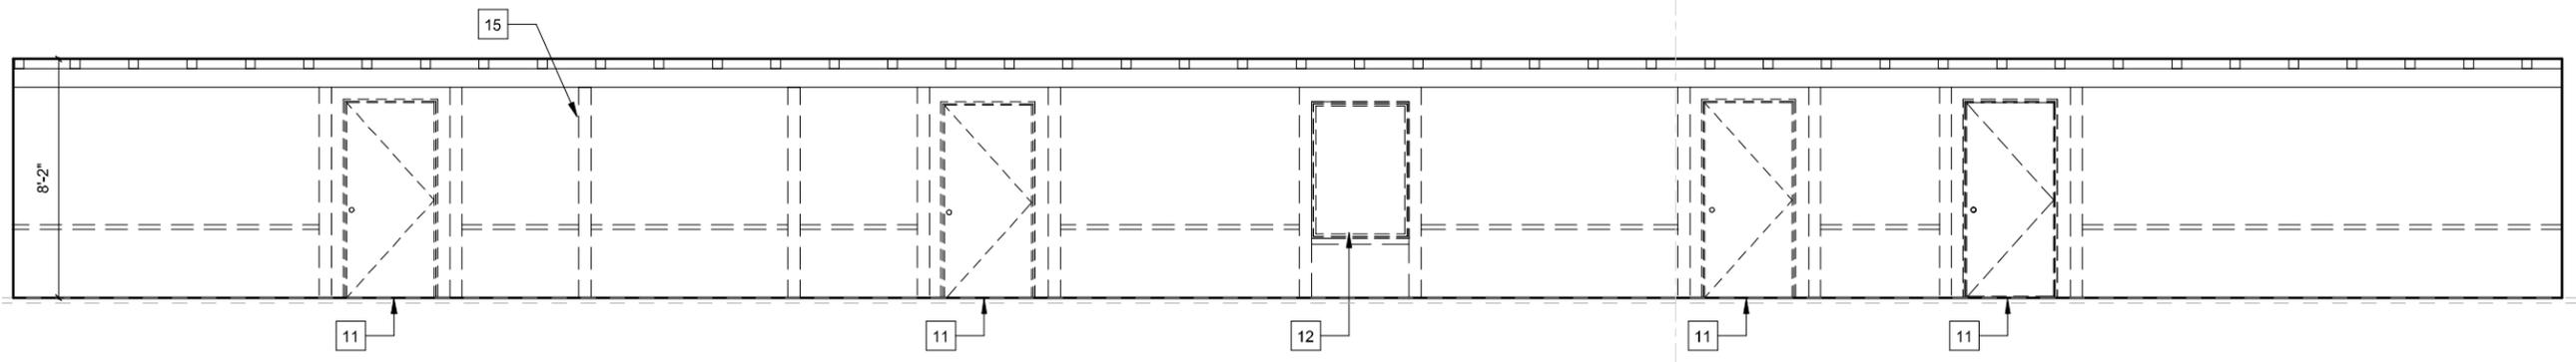
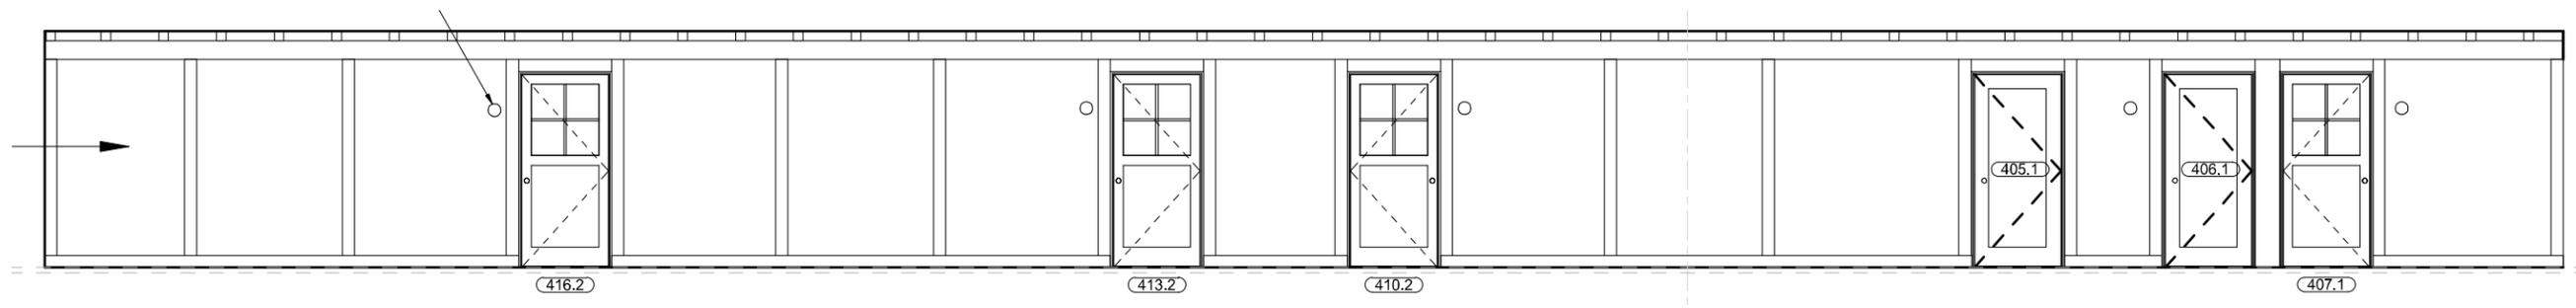
LIVING UNIT DOORS - 2021 CONDITION DEMO

LIVING UNIT DOORS - PROPOSED

DOOR LOCATIONS ADJUSTED TO BETTER SERVE THE FUNCTION OF THE UPDATED INTERIOR LAYOUT AND PROVIDE ACCESSIBLE ROUTE TO ADA UNIT. DOOR UNITS SHOWN IN 2021 CONDITION PHOTOS WERE NONHISTORIC FIBERGLASS AND ALUMINUM UNITS. ORIGINAL EXTERIOR COVERED PORCH TO BE RESTORED AND NONHISTORIC WINDOWS REMOVED.

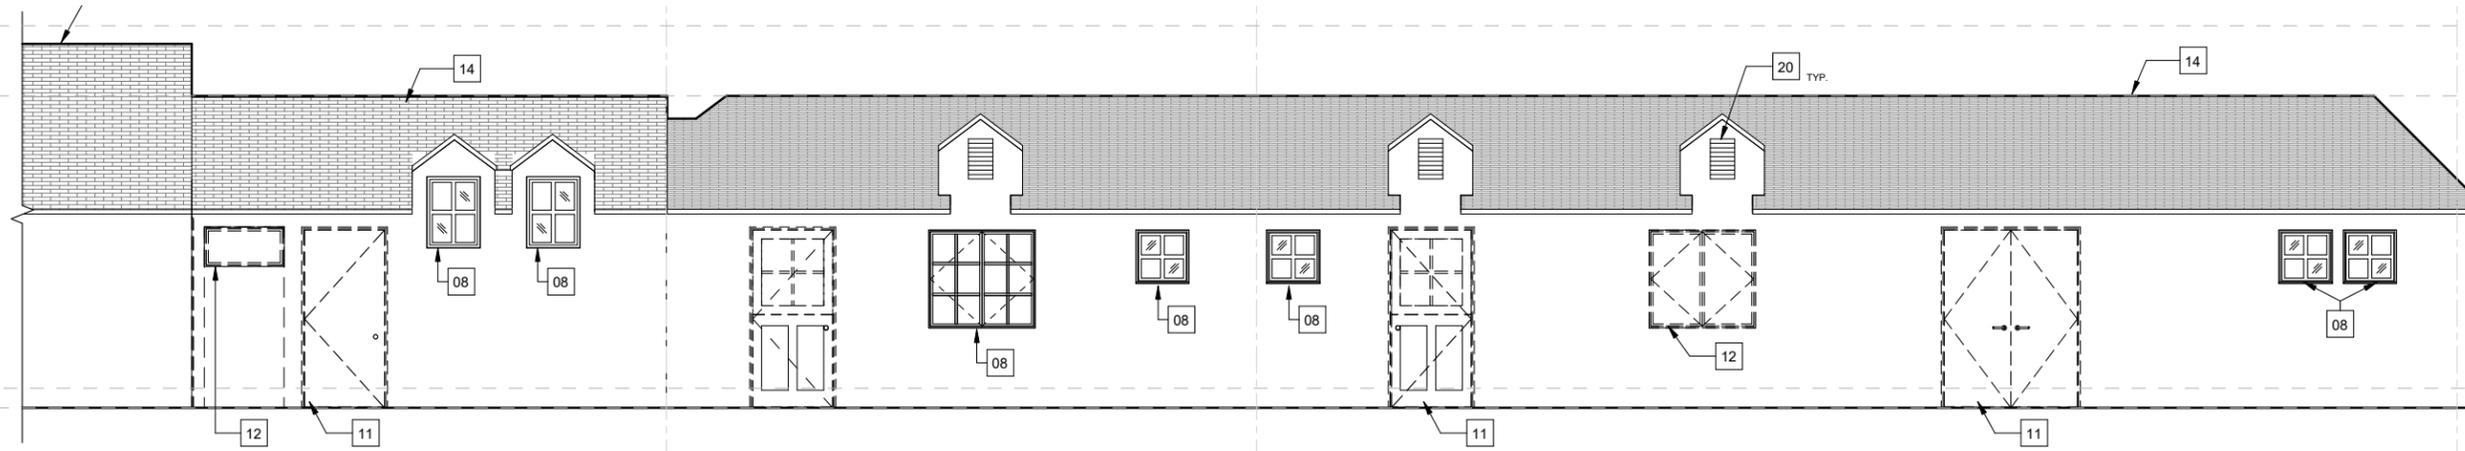
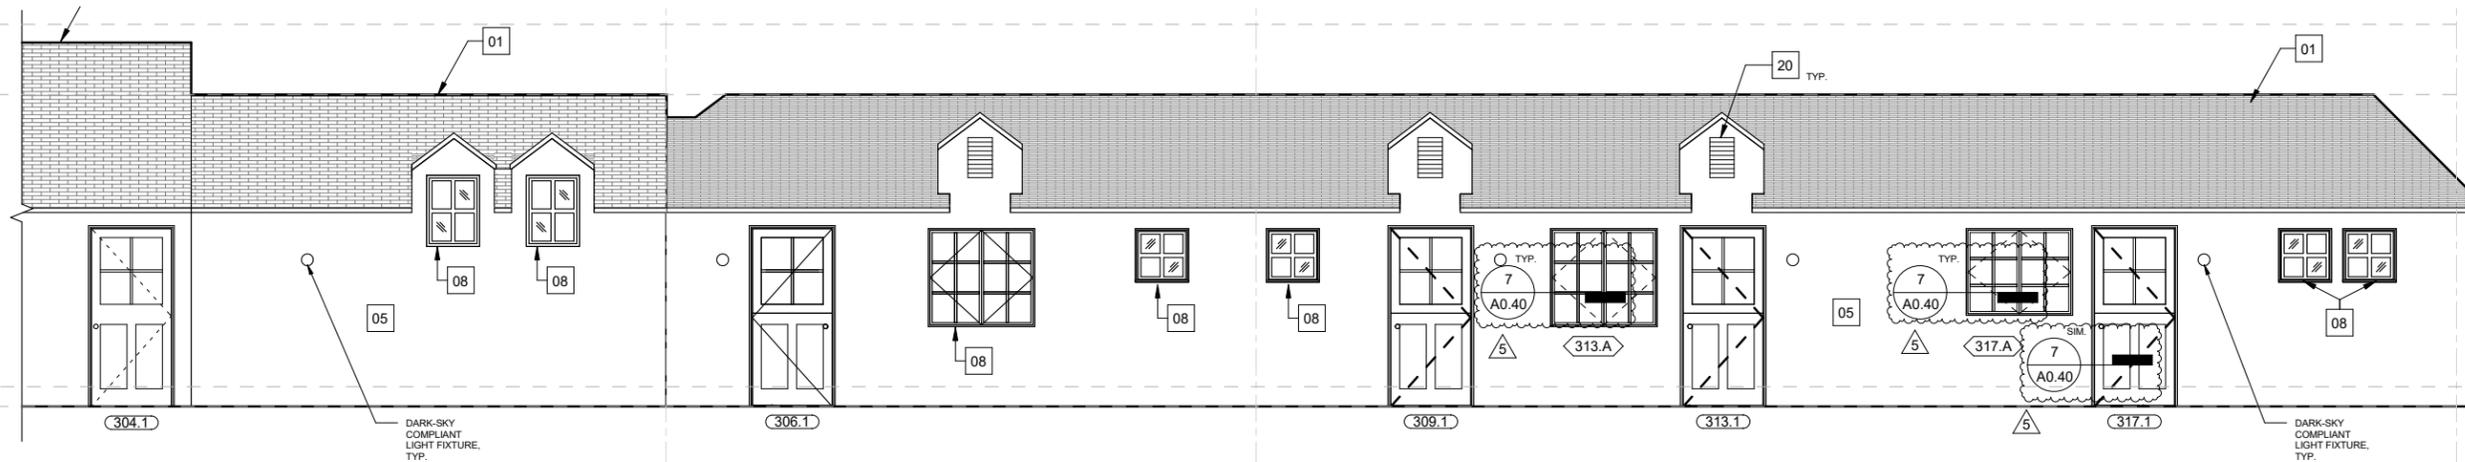
EAST - 2021 CONDITION DEMO

EAST - PROPOSED

DOOR LOCATIONS ADJUSTED TO BETTER SERVE THE FUNCTION OF THE UPDATED INTERIOR LAYOUT AND PROVIDE ACCESSIBLE ROUTE TO LAUNDRY. UNITS AT ADJUSTED FENESTRATIONS DETAILED TO MATCH INTACT HISTORIC UNITS.

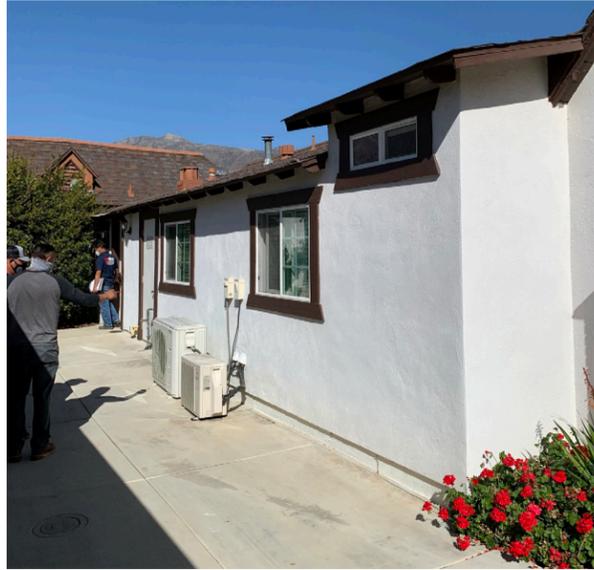
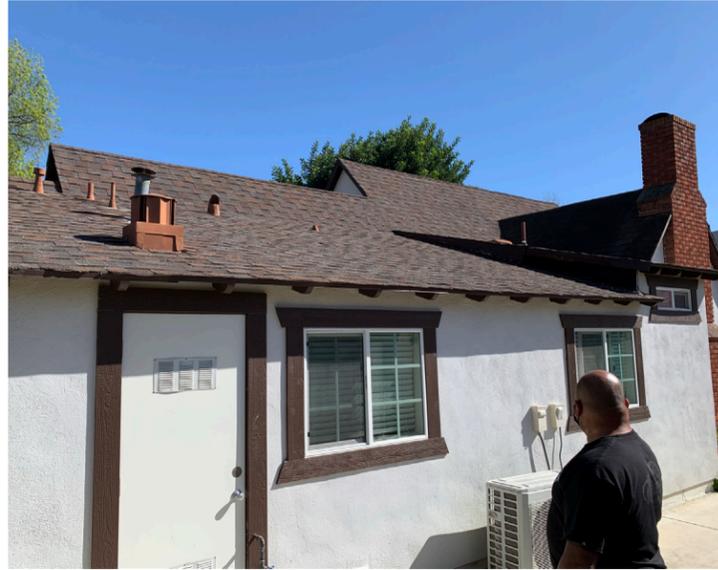
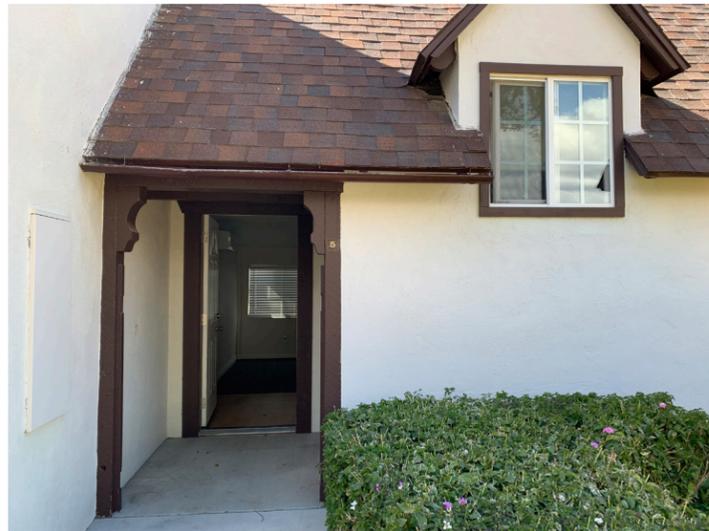
2021 CONDITION PHOTO - INFILL AREA BETWEEN DORMITORY AND POOL HOUSE REMOVED TO CREATE RESTORED BREEZEWAY

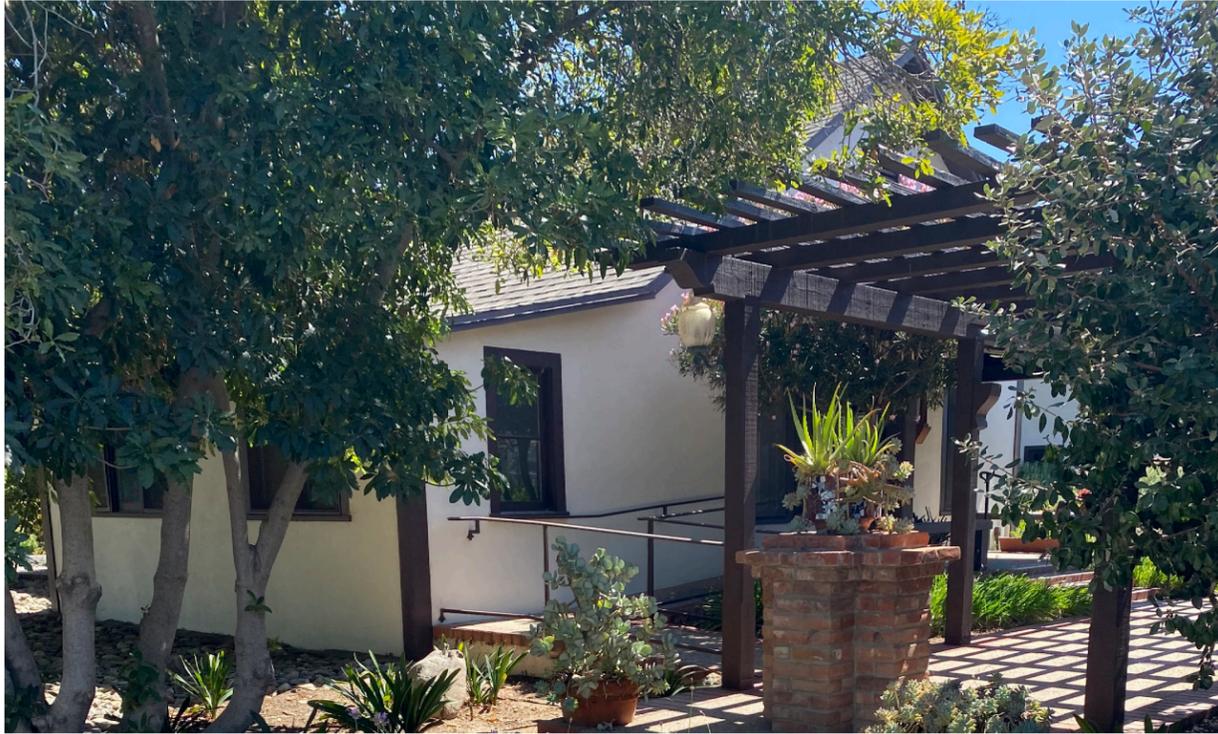
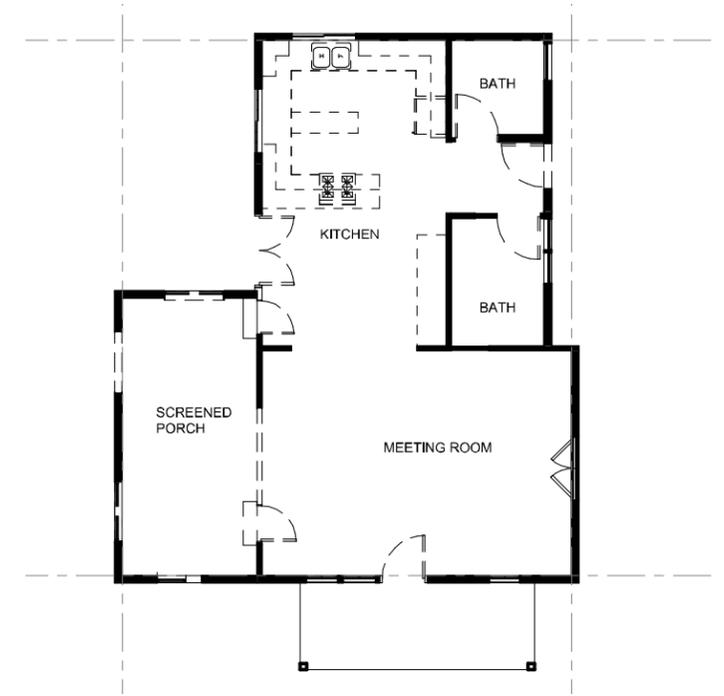
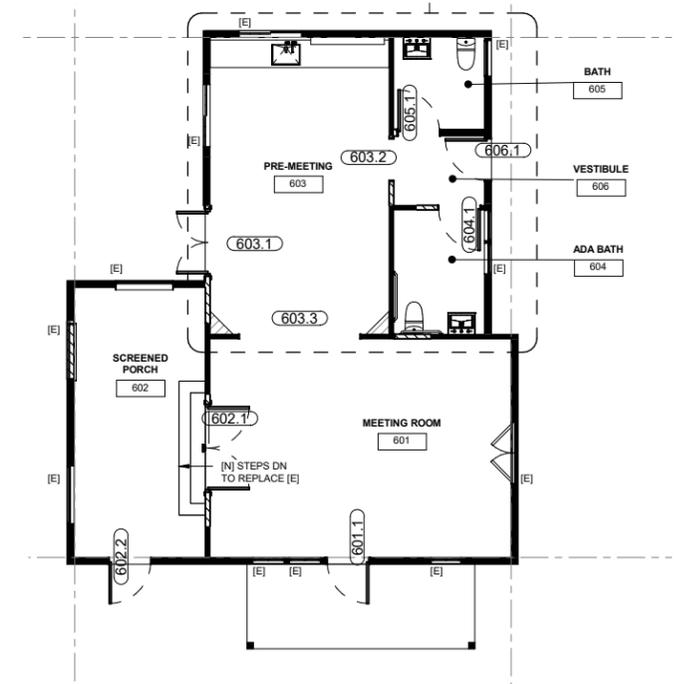
2021 CONDITION\_SOUTH-WEST

ALL FENESTRATIONS ARE EXISTING TO REMAIN. DOOR 602.2 HAS BEEN ADDED TO THE SCREENED PORCH IN ORDER TO CREATE A STEP FREE EGRESS.

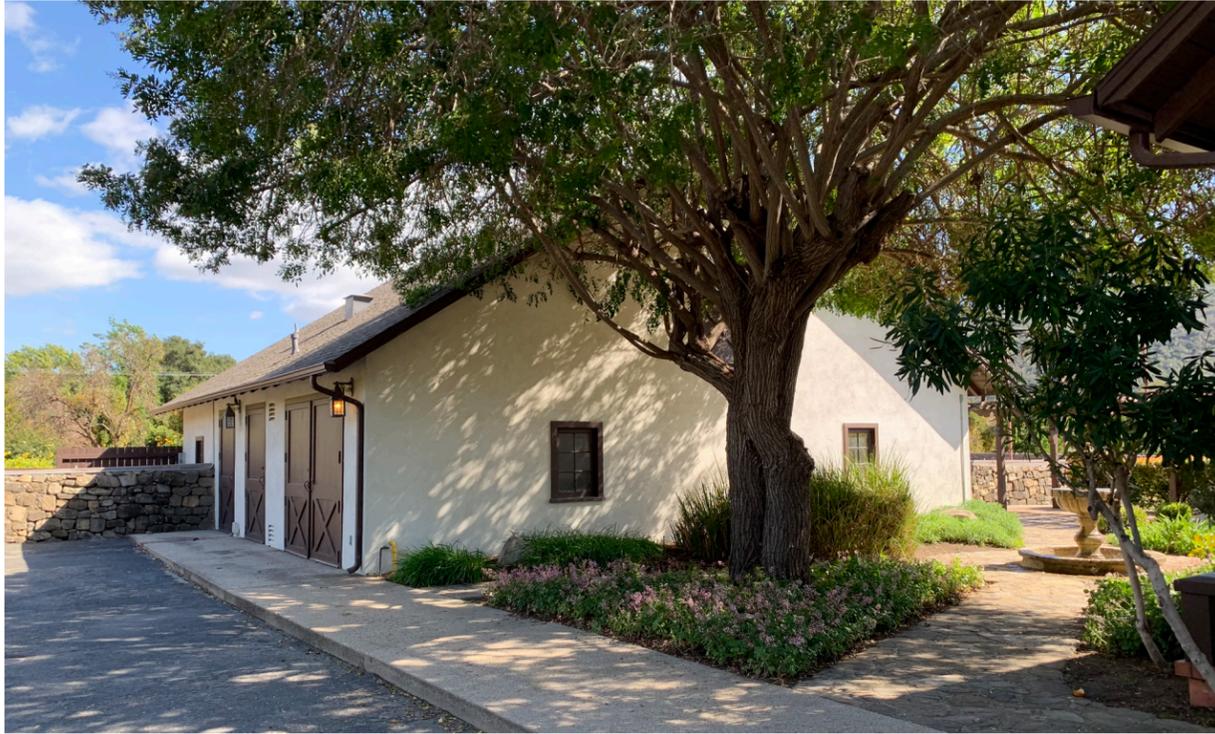
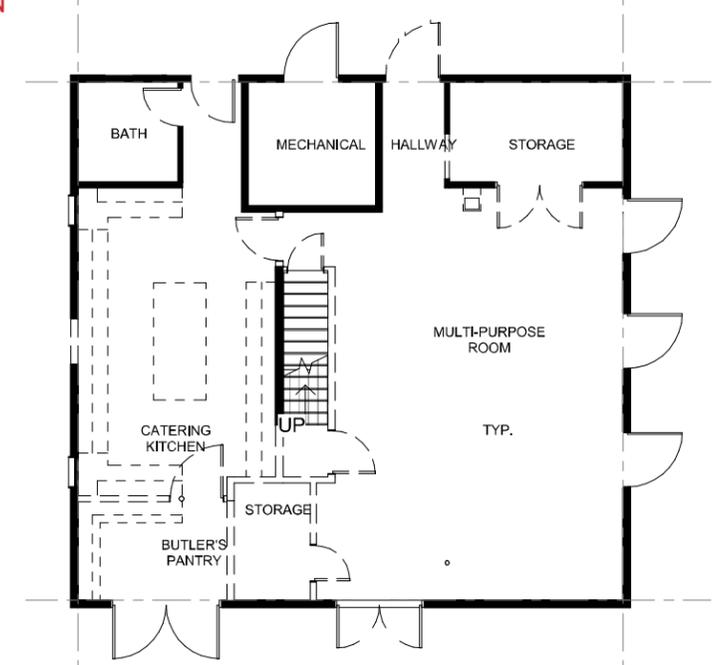
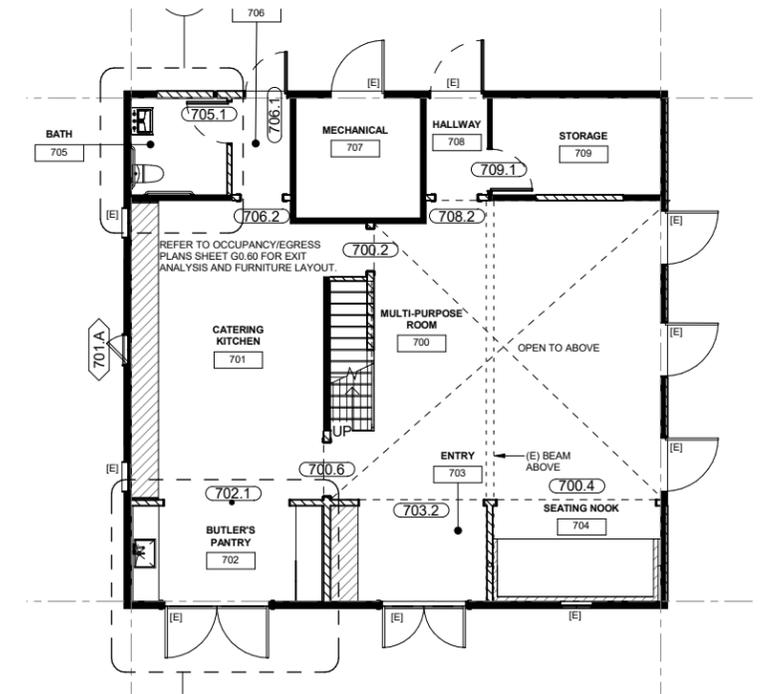
2021 CONDITION\_NORTH-WEST

ALL OPENINGS ARE EXISTING TO REMAIN WITH THE EXCEPTION OF (1) WINDOW. UNIT 701.A IS A SINGLE ORIGINAL WOOD WINDOW TO BE REINSTALLED AT EAST ELEVATION DURING RENOVATION

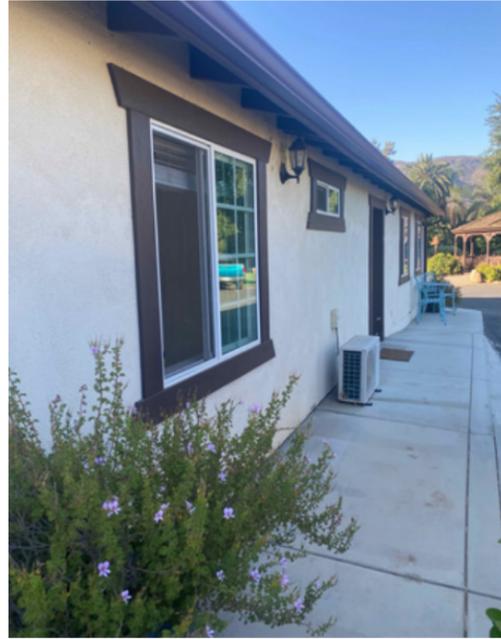
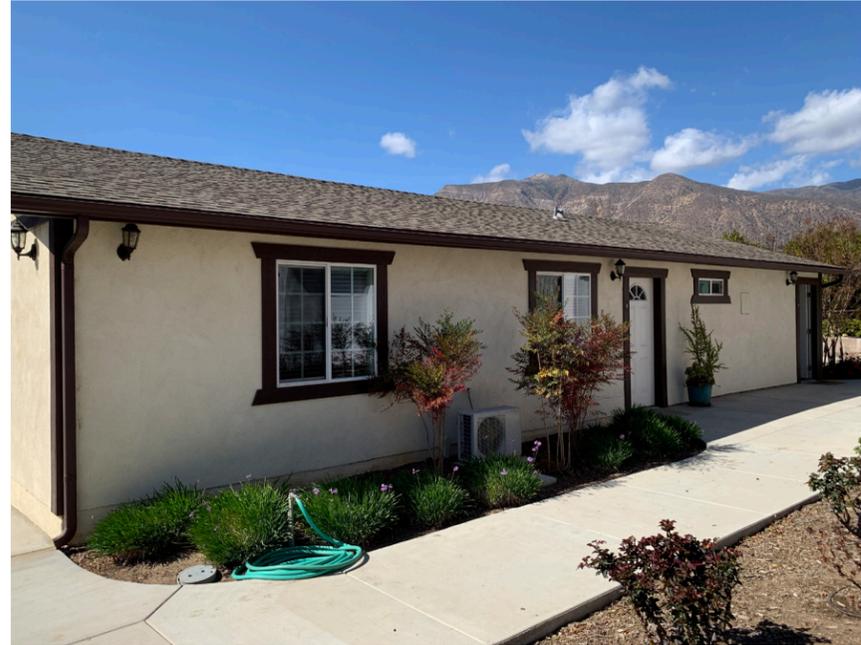
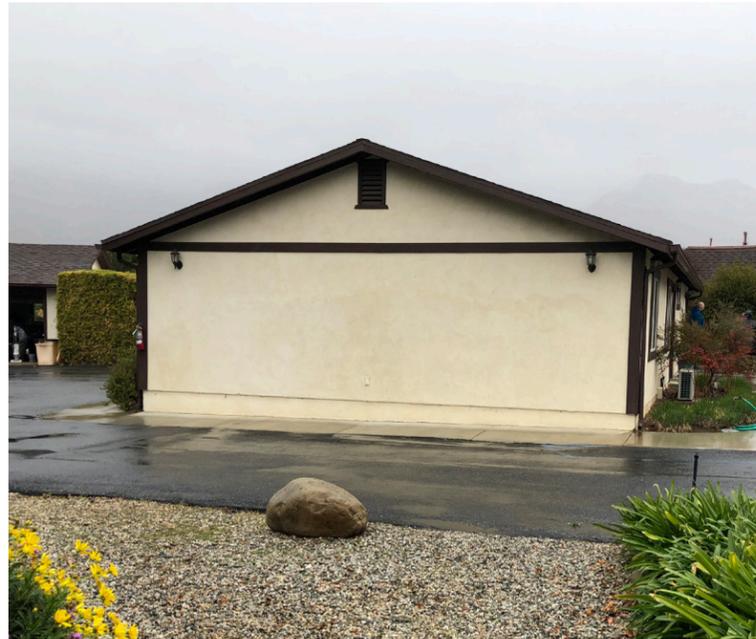
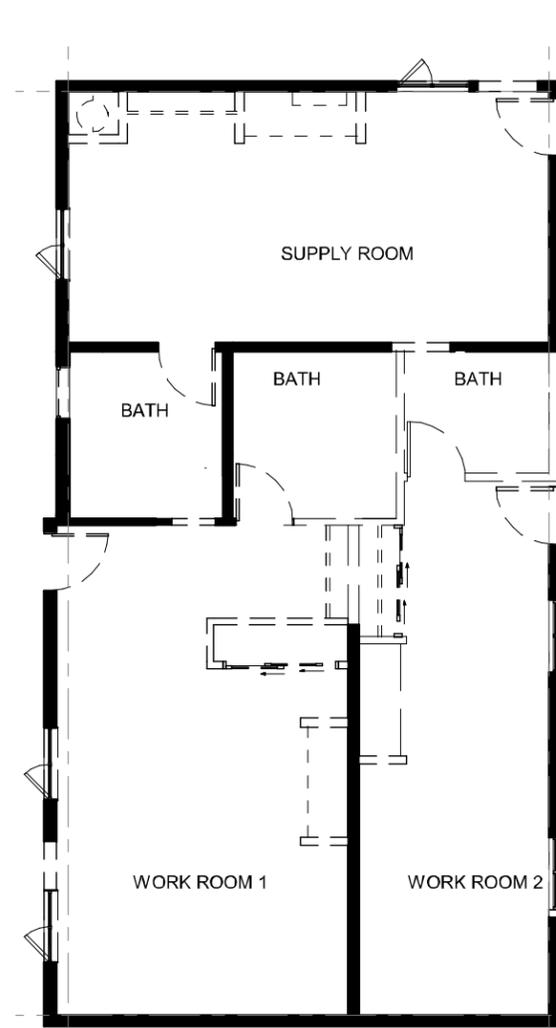
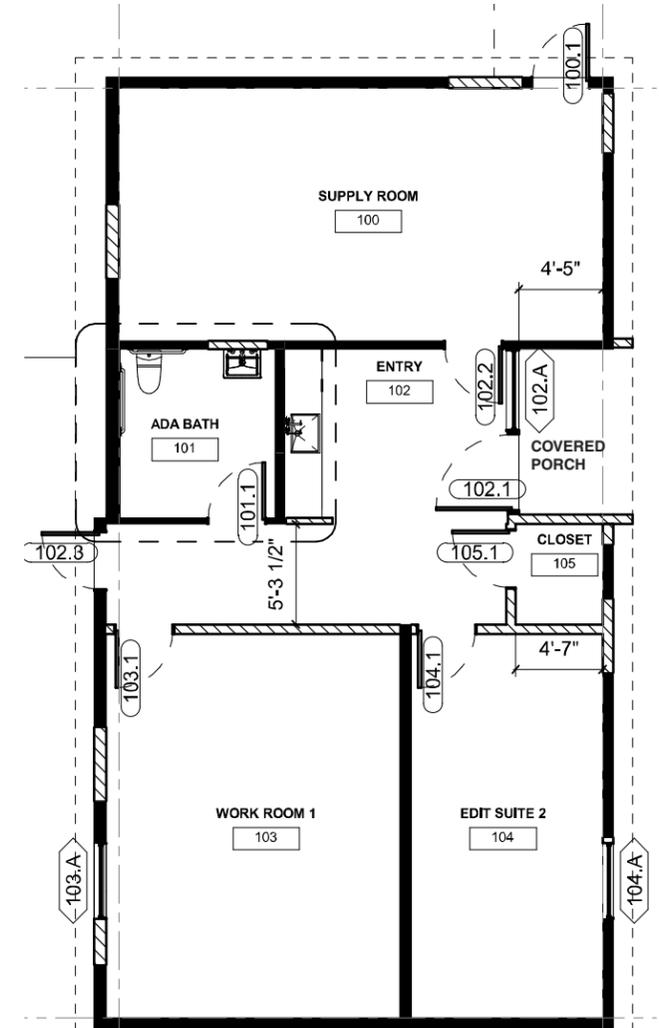
FENESTRATION CHANGES WERE MADE TO BETTER SERVE THE FUNCTION OF THE UPDATED INTERIOR LAYOUT. DOOR AND WINDOW UNITS SHOWN IN 2021 CONDITION PHOTOS WERE NONHISTORIC FIBERGLASS AND ALUMINUM UNITS.
