**Historic Resources Report, Phase 1 and 2
2464 E. Ojai Avenue
Ojai, Ventura County, CA**

14 April 2022

County of Ventura
June 12, 2023
Cultural Heritage Board Meeting
Item 6d
Exhibit 3 – Historic Resources Report, April
14, 2022

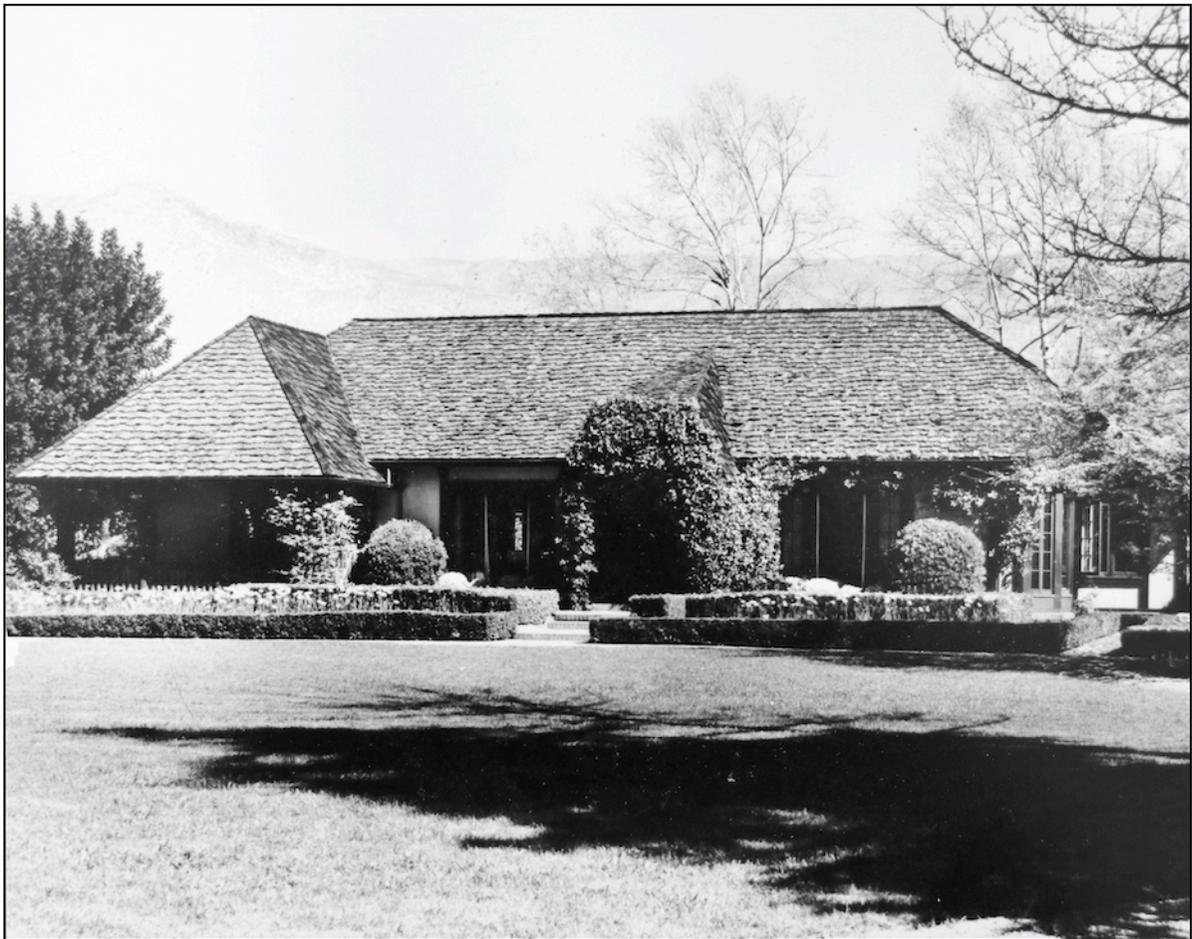
Figure 2. Weist House, southern elevation (Undated historic photo, possibly c. 1955).

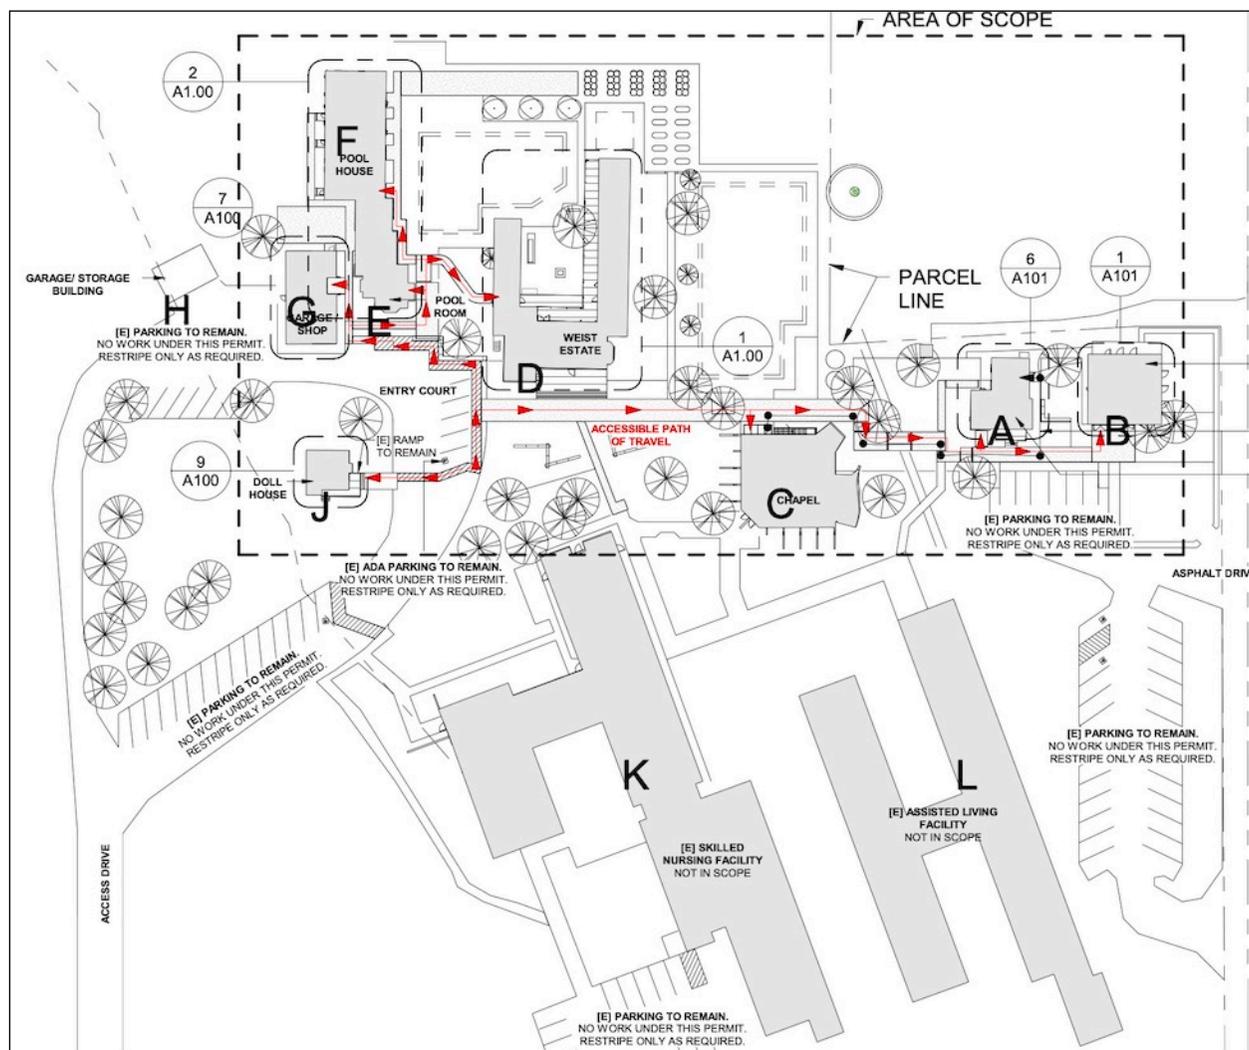
The property consists of ten buildings constructed between circa 1915 and 1982, listed and summarized in Table 1 below and described in this section. The plan reference letters correspond to the site plan included below as Figure 4. General note: Many of the window and door openings on all of the buildings are currently vacant. These building materials are stored onsite for renovation.

Figure 4. Building Locations (Bestor Architects, 2022).

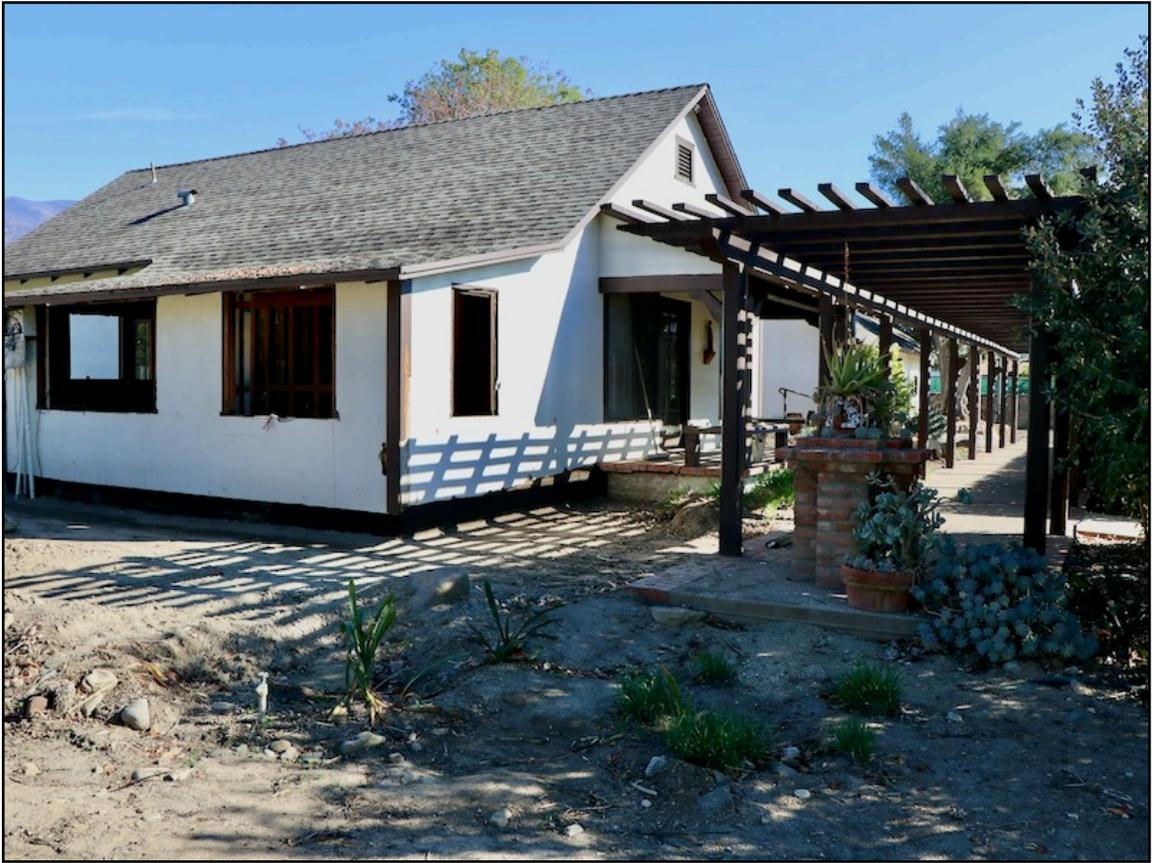
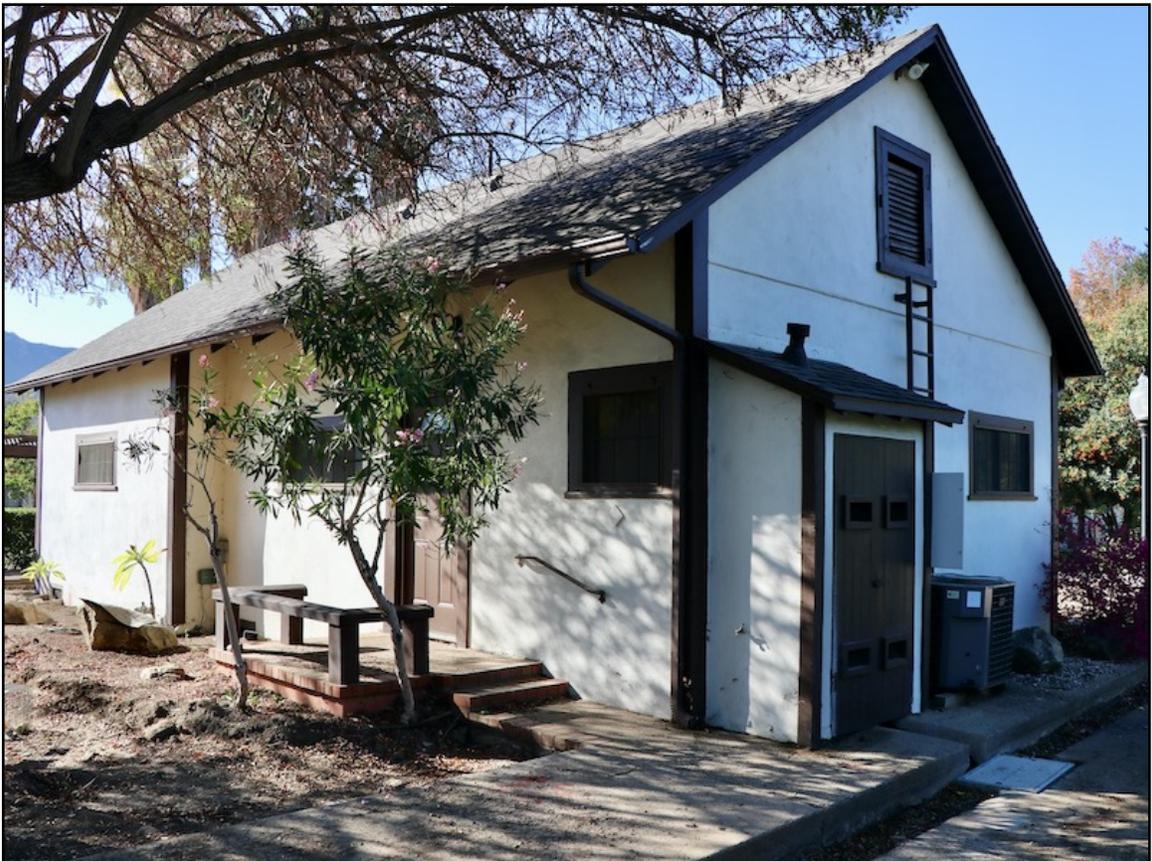
A. Residence. This single-story residence features an irregular plan and a high-pitched front-facing gable roof with shallow open eaves over the main body of the building, and a low-pitched shed-roofed wing on the western elevation. A louvered wood vent is located in the southern gable end and a larger louvered vent/attic access door is found on the northern gable end. A medium-pitched shed roof projects over the front entry on the southern elevation. The building is clad in stucco over single-wall construction. The extant windows are wood multi-pane surrounded by plain wood casings. According to Ventura County Assessor records, this building was constructed c. 1915, presumably as a residence, and was later converted to use as meeting room by St. Joseph’s. These records indicate that the western wing is an enclosed service porch, an alteration that took place in the mid-1960s. Other unspecified alterations took place during the early 1990s. The date of the

stucco cladding is unknown, but appears to predate these later alterations and may have occurred with the construction of the Main Residence and related construction in 1927.

Photo 1. Residence (Building A), viewed from southwest. [12-8-2021]

Photo 2. Residence [Building A], viewed from northeast. [12-8-2021]

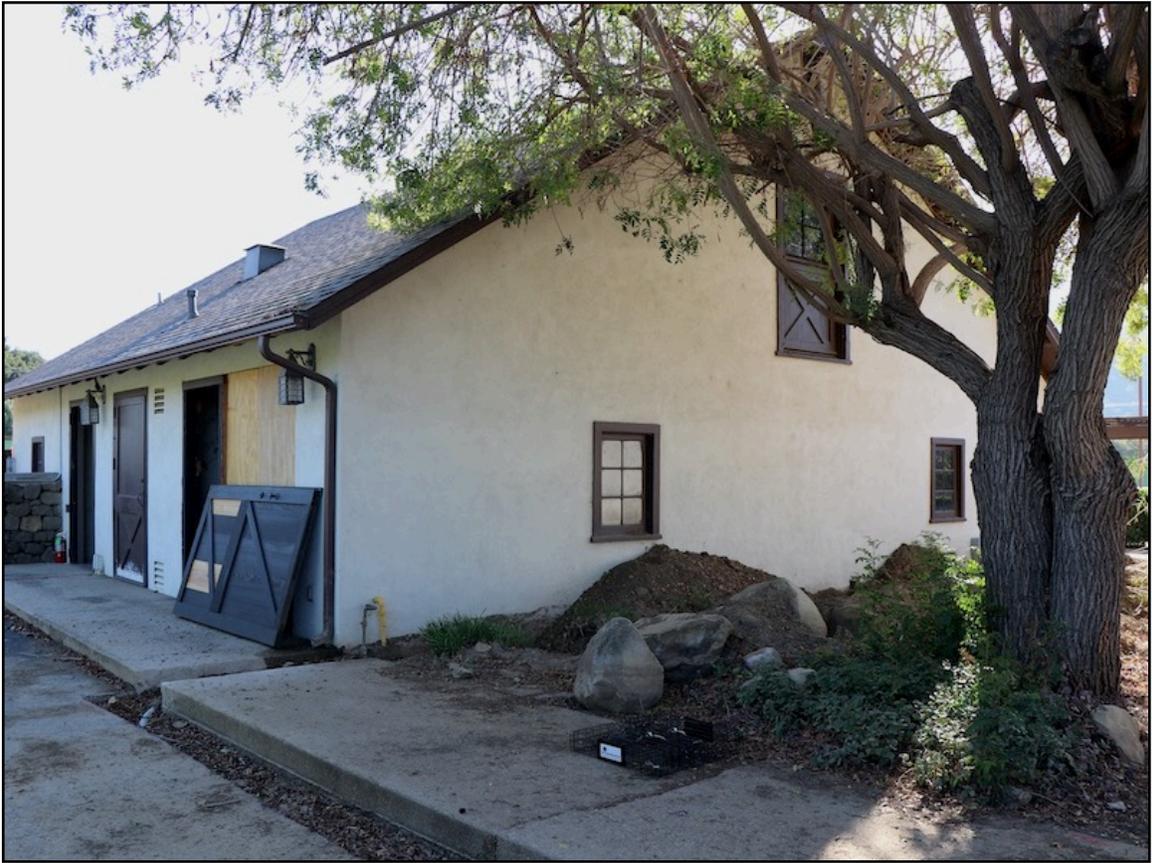
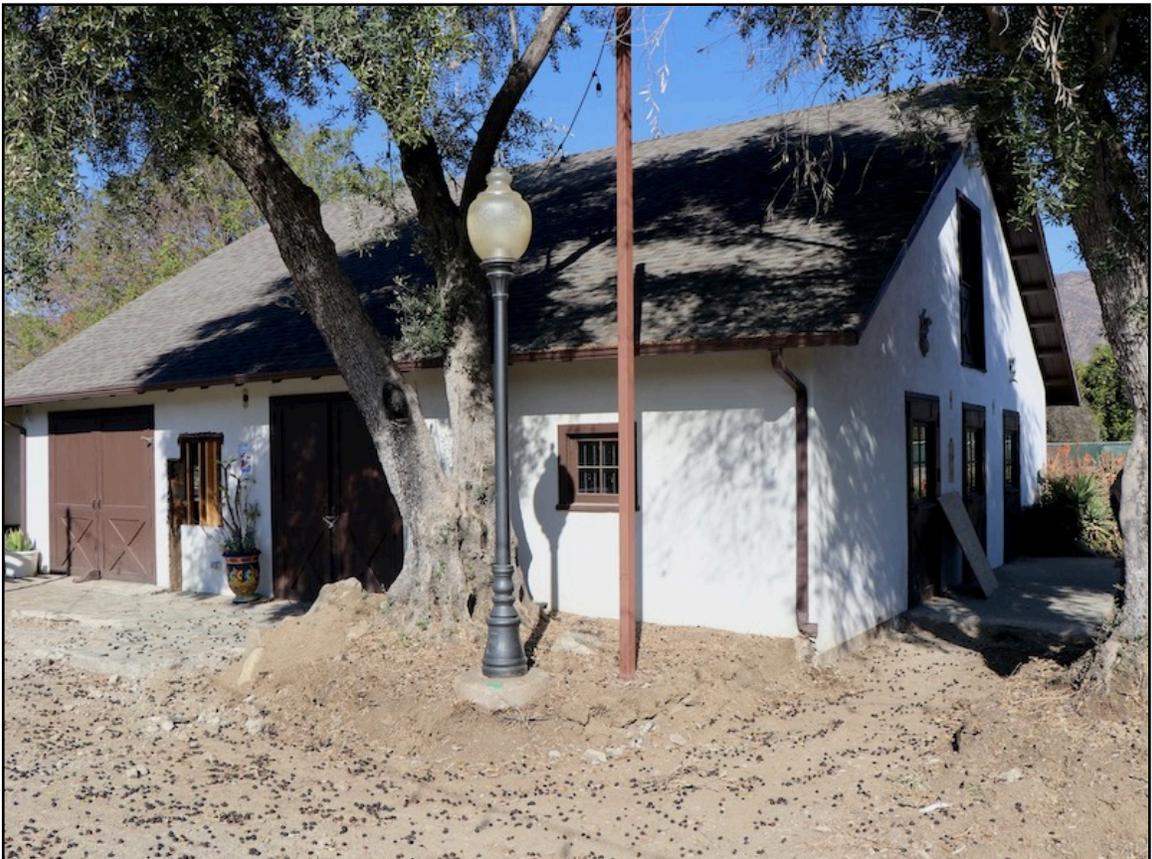
B. Barn/Stables. This one and a half-story building features a rectangular plan and a high-pitched side-facing gable roof with shallow, open eaves. Single and double large wood doors with an x-pattern in the lower half are found on the northern and southern elevations. Wood doors with a similar design and two-over-two-light windows in the upper portion of the gable ends presumably originally accessed a hay loft. Windows are multi-pane wood with plain wood casings. According to Ventura County Assessor records, this building was constructed c. 1915, presumably as a barn or stables, and was later converted to use as meeting room by St. Joseph's. These records indicate unspecified alterations took place during the early 1990s. The date of the stucco cladding is unknown, but appears to predate the later alterations and may have occurred with the construction of the Main Residence and related construction in 1927.

Photo 3. Barn/Stables (Building B), viewed from northwest. [12-8-2021]

Photo 4. Barn/Stables (Building B), viewed from southeast. [12-8-2021]

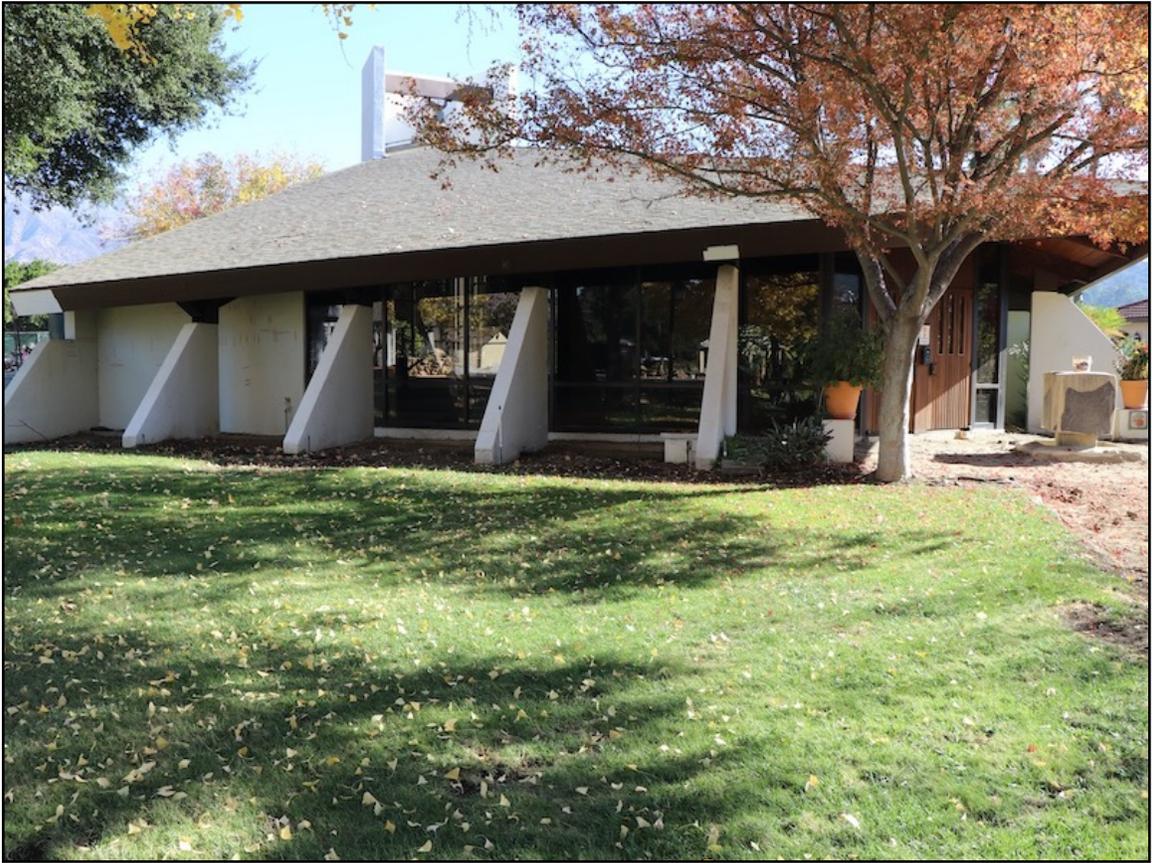
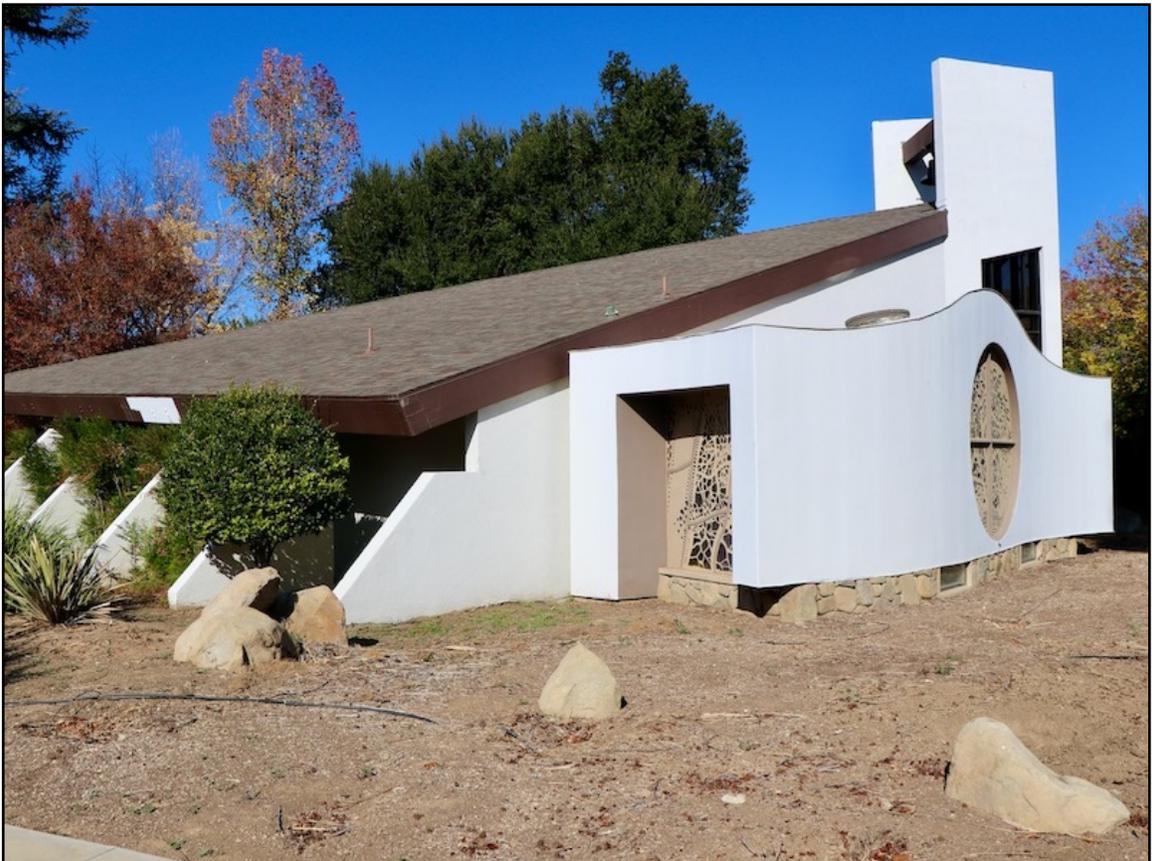
C. Chapel. This single-story building constructed in 1981 features a roughly square plan with a truncation of the southwestern corner to form the entry. The roof is a moderately-pitched hip, perhaps better described as a folded shed, supported by a series of angled pylons on the southern and western elevations projecting over the entry at the southwestern corner and terminated at a bell tower at the northeastern corner. Windows are aluminum frame fixed, floor to ceiling, with a tripartite window forming the chancel under the tower. A confessional added to the eastern elevation in 1998 is roughly rectangular in plan but free-form and features inset stained glass windows.

Photo 5. Chapel (Building C), viewed from west. [12-8-2021]

Photo 6. Chapel (Building C), viewed from southeast. [12-8-2021]

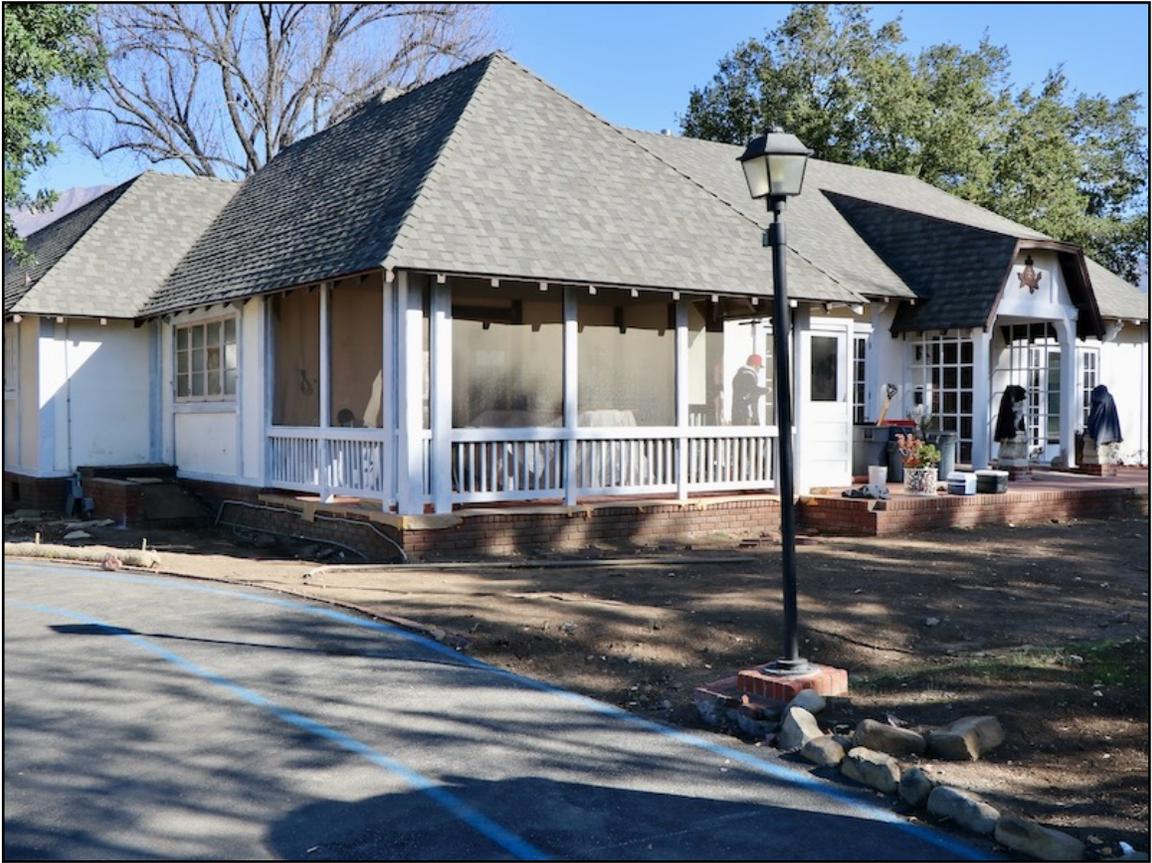
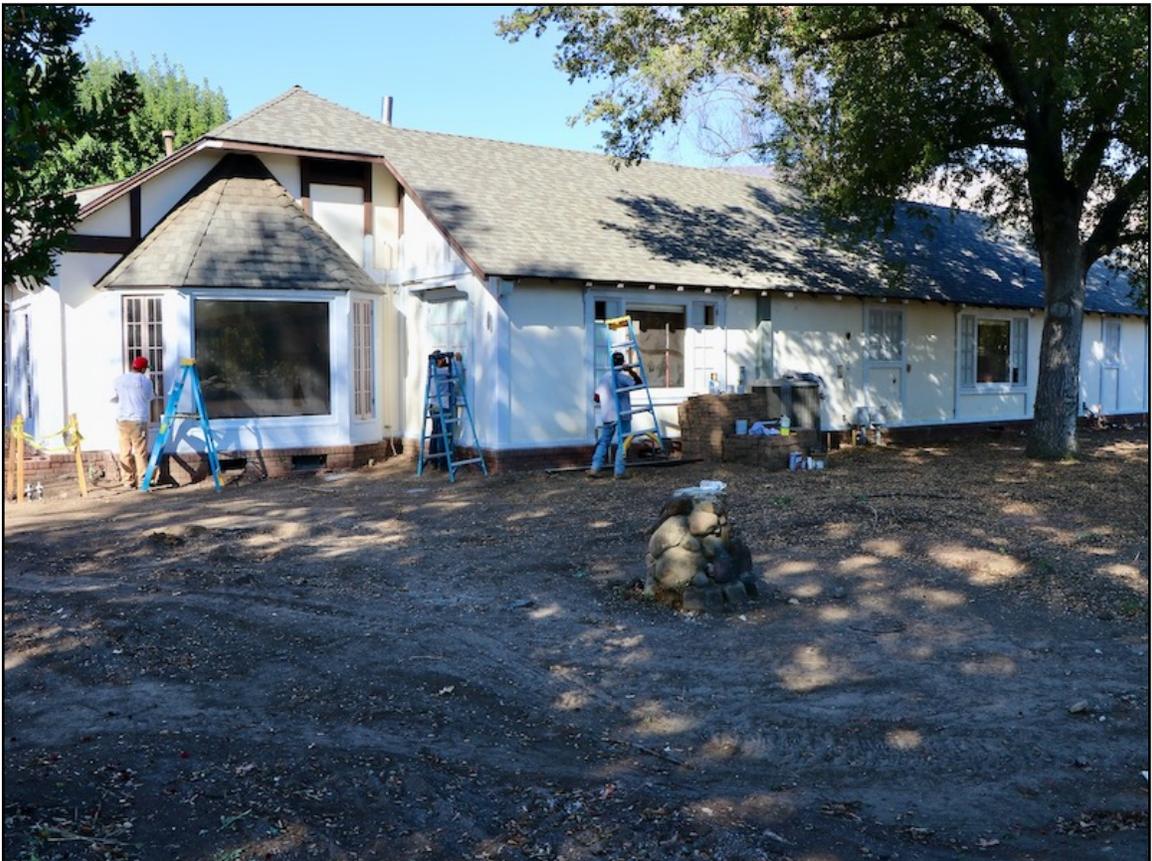
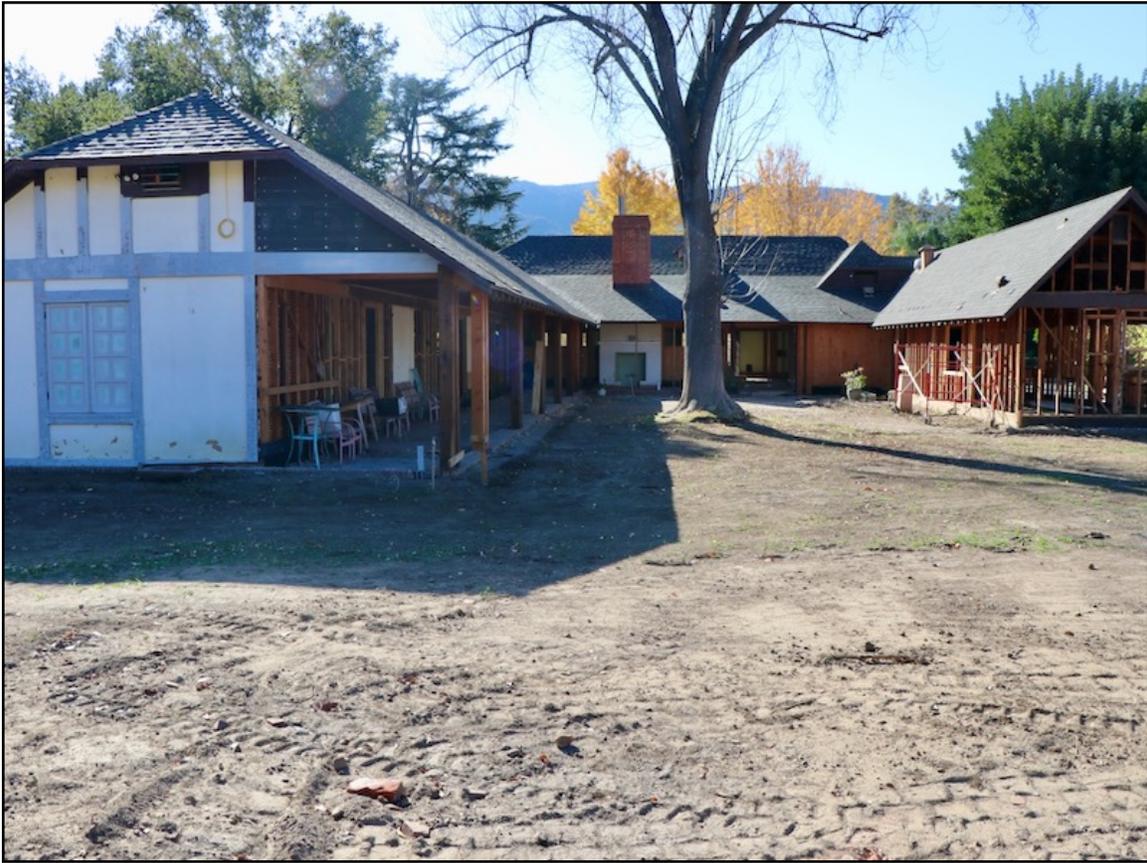
D. Main Residence. This single-story residence constructed in 1927 features a u-plan with wings projecting to the rear (north) forming a courtyard between. The main body of the house features a steeply-pitched side-facing hipped roof with a hipped roof intersecting on the western side projecting over a porch surrounded by a wood porch rail and supported by substantial chamfered wood posts. A smaller gambrel roof projects over a covered entry roughly centered on the southern elevation, supported by wood posts. The two wings are gable-roofed, with the longer, eastern wing clipped with a jerkenhead. Eaves are shallow and open with exposed rafter tails. The southern portion of the residence is constructed on a raised brick foundation that also forms a full-front porch across the southern elevation; the balance is constructed on a concrete perimeter. The residence is stucco-clad and features faux half-timbering details. Windows are mainly wood-frame multi-paned casements. A proportion of the exterior cladding was recently removed down to the studs, particularly on the western wing and the western elevation of the eastern wing.

The residence is known to have been altered in several respects since construction, particularly at the rear, to accommodate the hospital use of the building. Included is the enclosure of an open porch along the western elevation of the eastern wing to form a solarium, and the enclosure of a smaller porch on the western wing. A number of window and door opening were also altered, opened, or closed. Some of these changes are revealed in the exposed framing. The dates of these alterations are undocumented, but Ventura County Assessor records suggest that they took place primarily if not entirely prior to 1964, but some could have been made in an ad-hoc fashion at any time between the 1950s and the 1990s. Historic photos also indicate that the original wood shingle roof was laid in a rustic pattern to imitate thatching, a feature since replaced with asphalt shingles laid in a conventional pattern.

Photo 7. Main Residence (Building D), viewed from southwest. [12-8-2021]

Photo 8. Main Residence (Building D), viewed from east. [12-8-2021]

Photo 9. Main Residence (Building D), viewed from north. [12-8-2021]

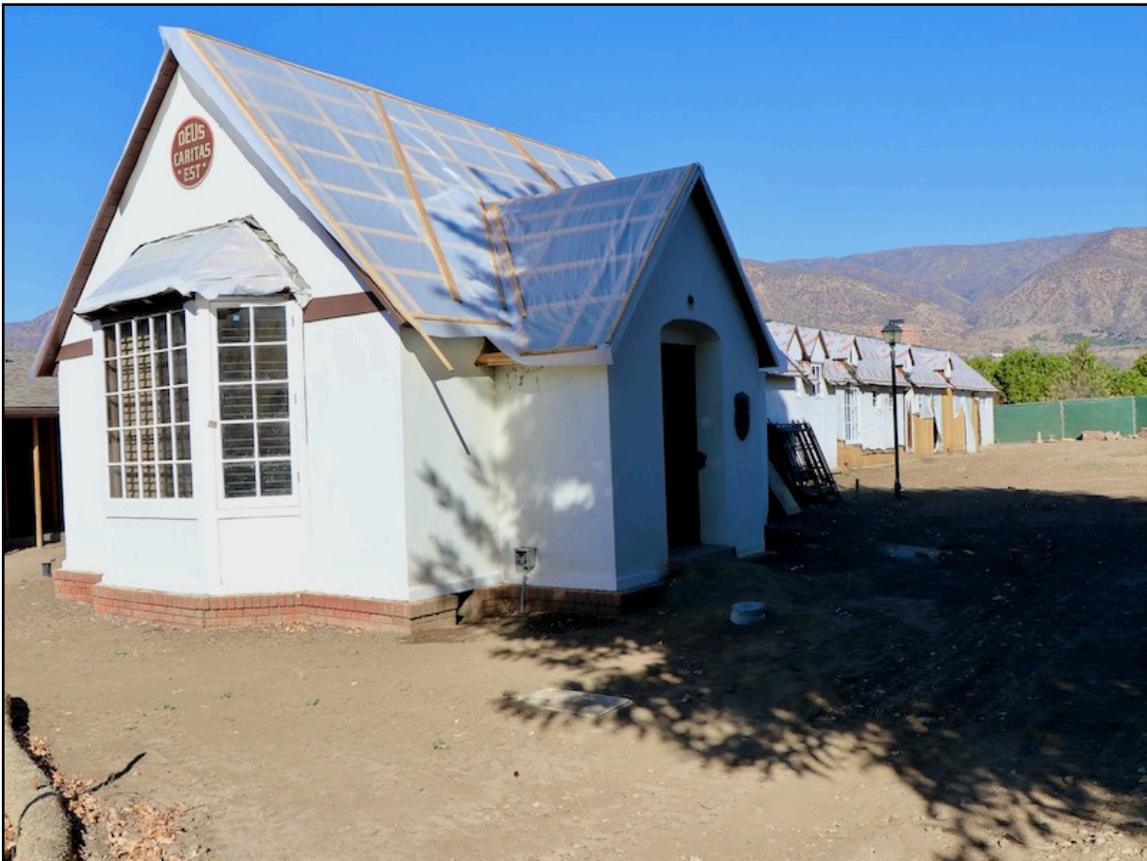
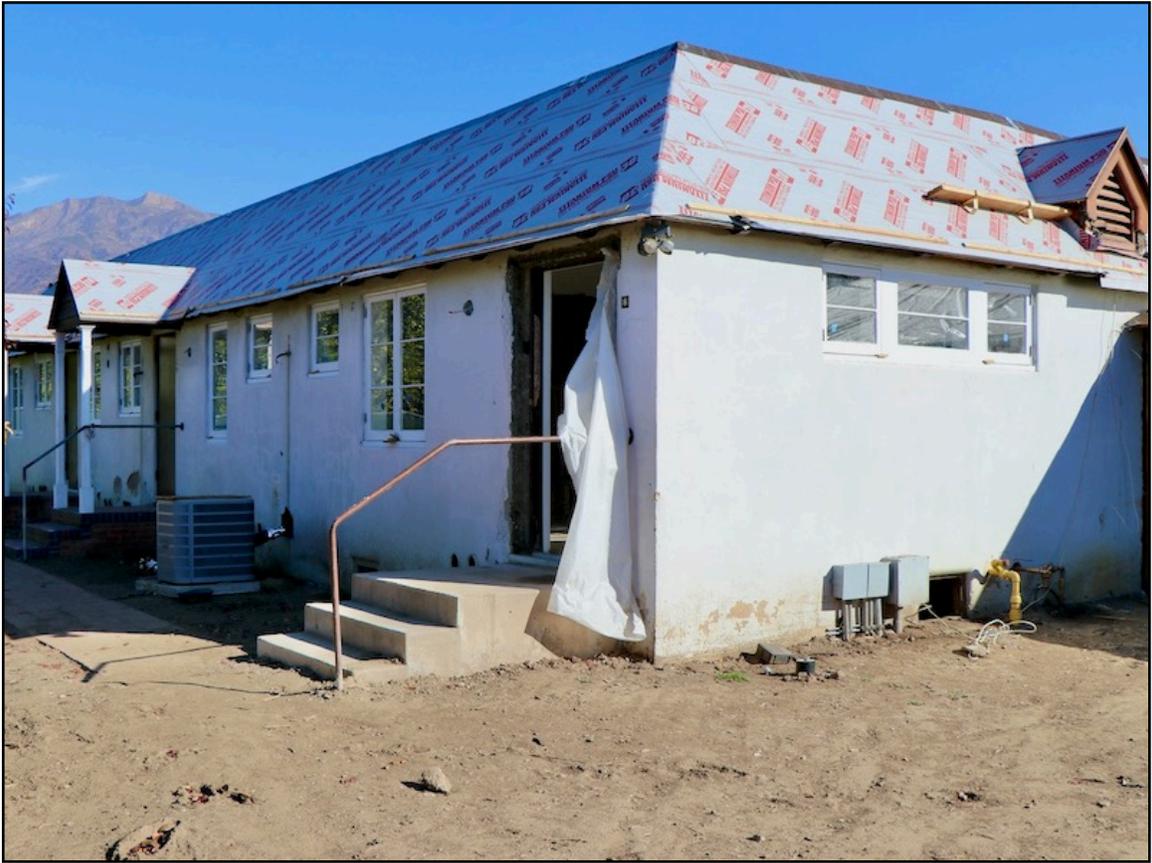
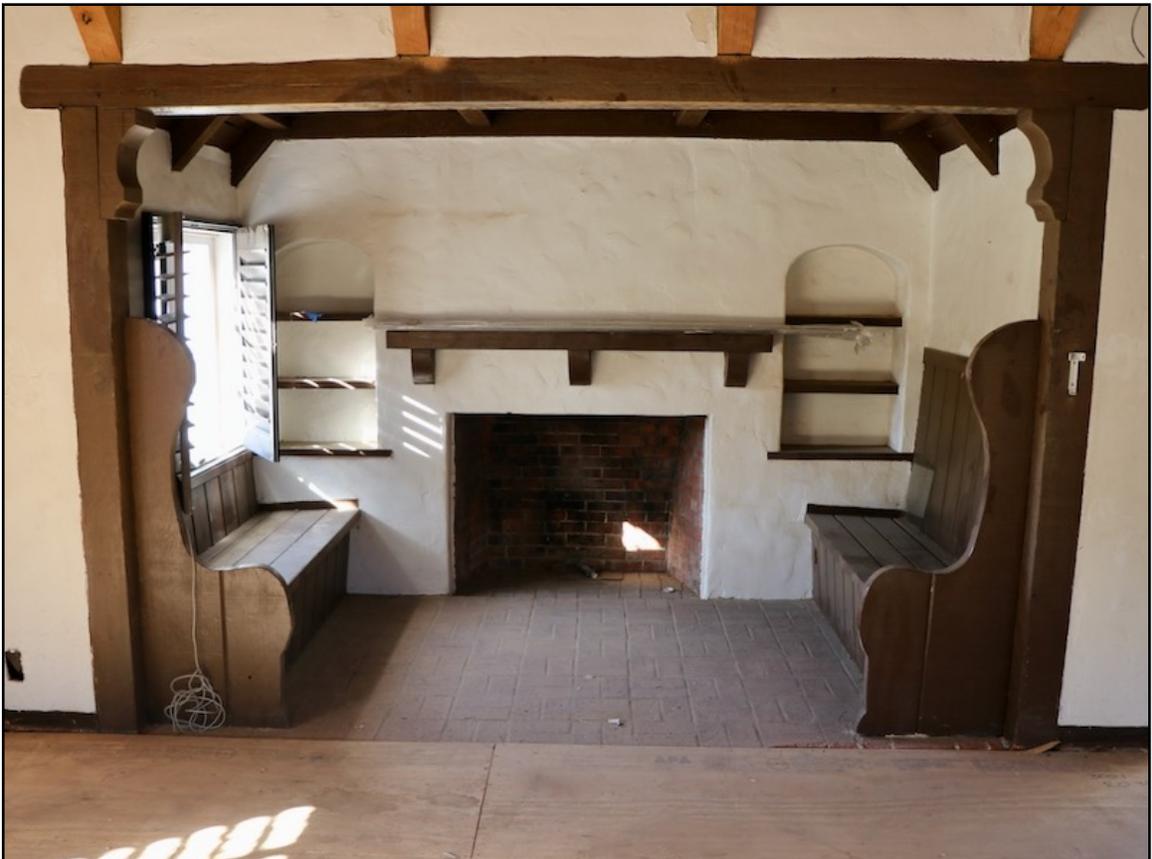
E/F. Recreation Room/Dormitory. This single-story, stucco-clad building with an irregular plan was apparently originally constructed in 1927, probably as two buildings, since joined and connected by a breezeway. The southern portion of the building consists of a wing covered with a front-facing, high-pitched gable roof with shallow eaves and a tripartite bay window. A lower intersecting gable facing east encloses the main entry. This portion of the building, apparently constructed as a recreation room, features a high, opened-beamed ceiling and a fireplace set within an inglenook on the interior. The wing to the south of the breezeway is characterized by two, lower gable roofs stepped back within each other and high-pitched gable dormers on the eastern elevation. The original use of this portion of the building was apparently as cabañas for the pool, formerly located immediate to the east. The northern wing features a high-pitched mansard roof with gabled dormers on the eastern elevation and two entries on the western elevation consisting of intersecting gables forming porches over low concrete stoops and supported by wood posts. Windows are mainly wood multi-pane casements and sash. This wing probably originally functioned as housing for ranch employees and later was used as a dormitory for the hospital.

Photo 10. Recreation Room/Dorm (Building E/F), viewed from southeast. [12-8-2021]

Photo 11. Recreation Room/Dorm (Building E/F), viewed from southwest. [12-8-2021]

Photo 12. Recreation Room/Dorm (Building E/F, interior. [12-8-2021]

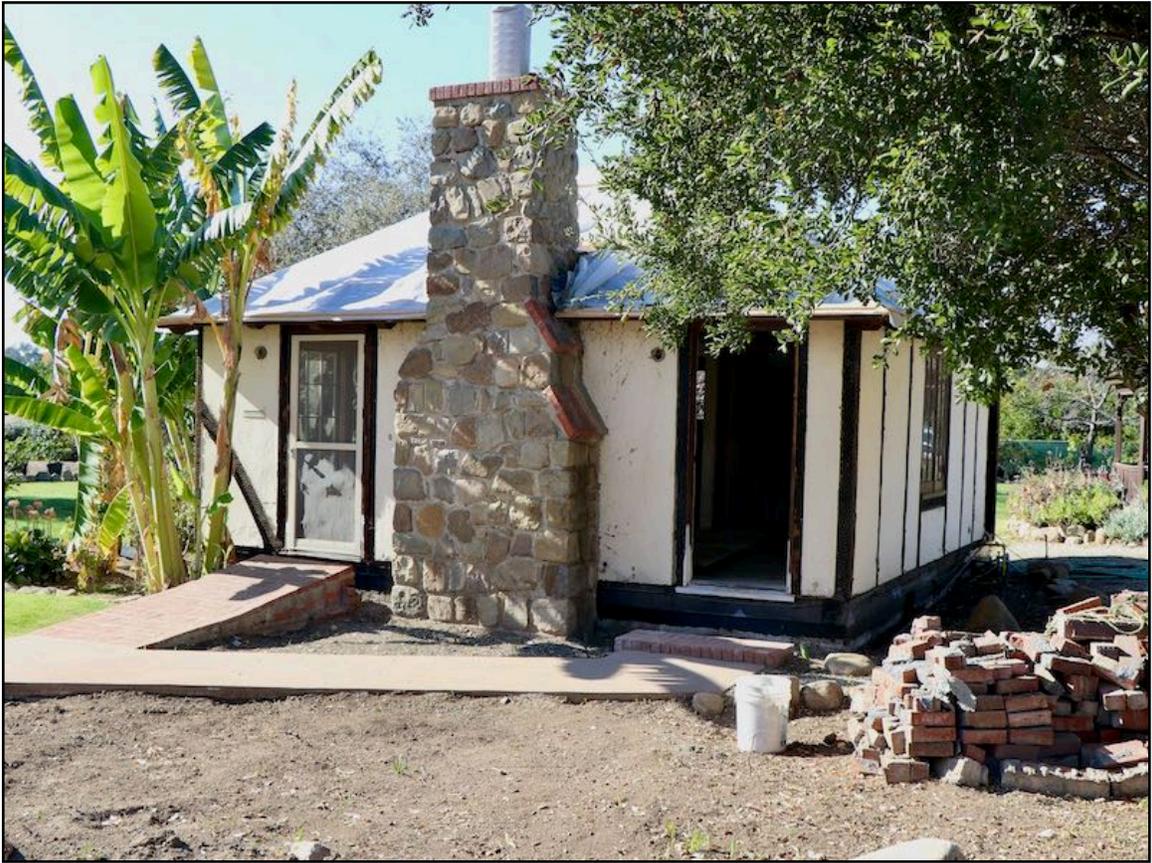
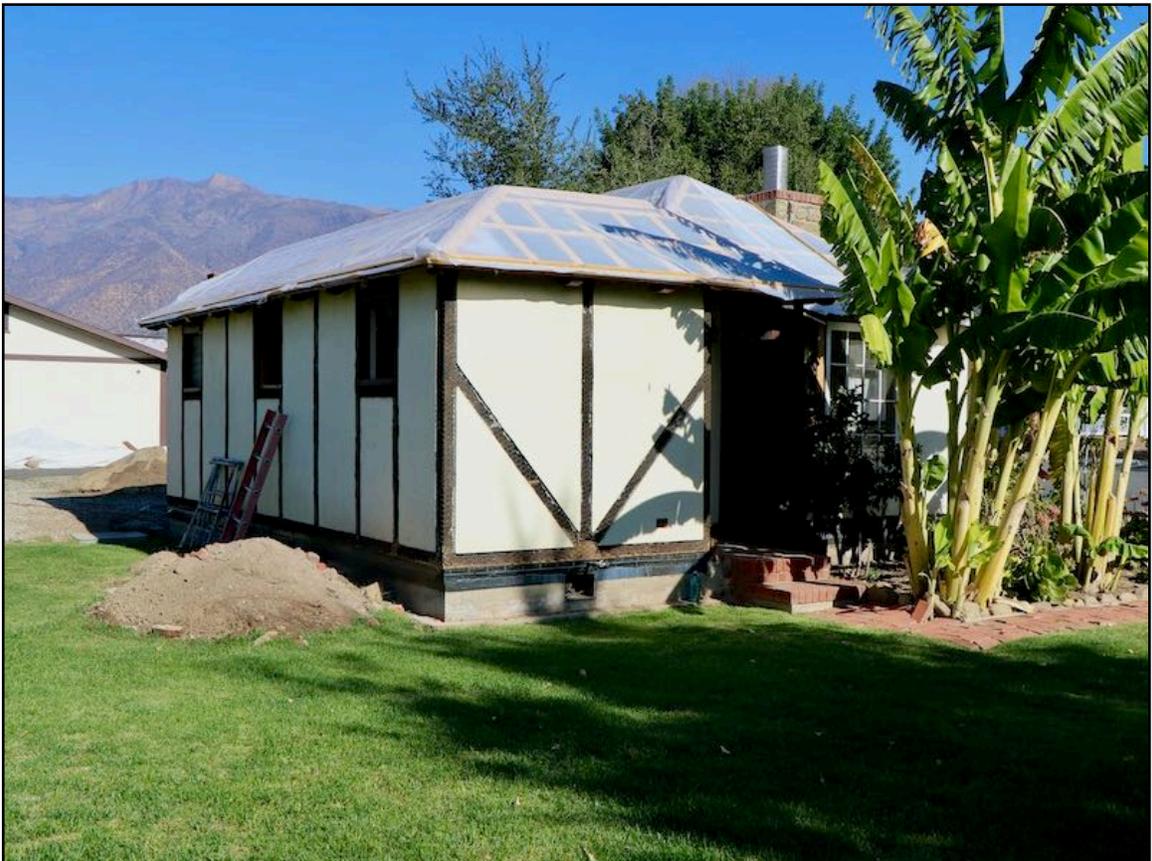
J. Doll House. This tiny, single-story building featuring a roughly square plan was constructed in 1927. It features a steep-pitched hip roof over an eastern wing (the original section of the building) and a mansard roof over the western wing, which according to assessor records was added in 1957. The building is stucco-clad and features faux half timbering and an exterior fireplace chimney of river rock centered on the eastern elevation with entries on either side. A third entry is found on the southern elevation above a brick stoop. The building was presumably constructed as a playhouse for the Weist's younger child, Mary. Though no documentation could be obtained, it was probably later used by St. Joseph's as an office.

Photo 15. Doll House (Building J), viewed from east. [12-8-2021]

Photo 16. Doll House (Building J), viewed from southwest. [12-8-2021]
