ARBORIST TREE ASSESSMENT REPORT

**STATE ROUTE 23
DRAINAGE RESTORATION PROJECT
VENTURA COUNTY, CALIFORNIA**

LSA Project No. GPA2202.01

July 2022

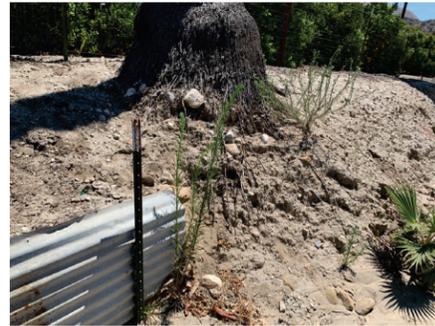
Tree 7 – Mexican fan palm in fair condition, palm tree stability may be compromised by roadside ditch erosion.

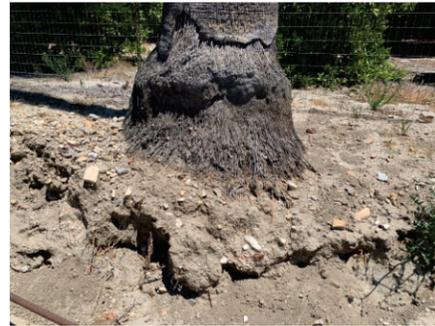
Tree 14 – Mexican fan palm in fair condition, adjacent to roadside ditch, provide root protection.

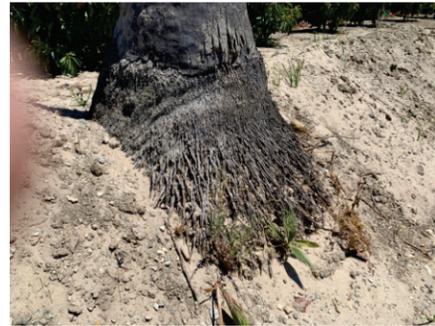
Tree 25 – Mexican fan palm in poor condition, palm tree stability compromised with exposed root ball by roadside ditch erosion.

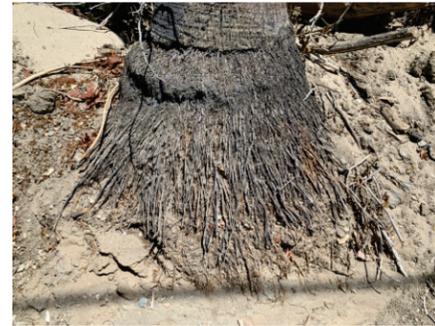
Tree 26 – Mexican fan palm in poor condition, palm tree stability extremely compromised with undercutting of exposed root ball by roadside ditch erosion.

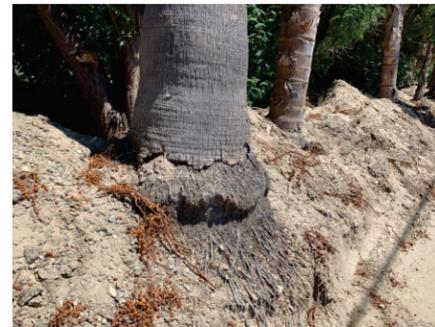
Tree 29 – Mexican fan palm in poor condition, palm tree stability compromised with exposed root ball by roadside ditch erosion.

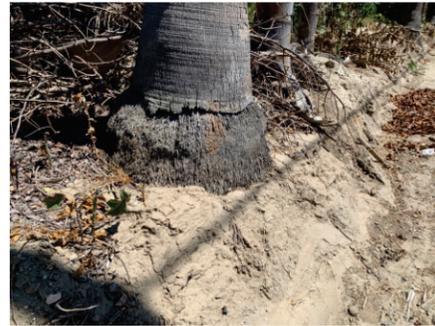
Tree 31 – Mexican fan palm in fair condition, palm tree stability compromised by roadside ditch erosion.
