Historic Resources Survey & Context for the

TOWN OF SATICOY

Historic Resources Survey & Context

Town of Saticoy

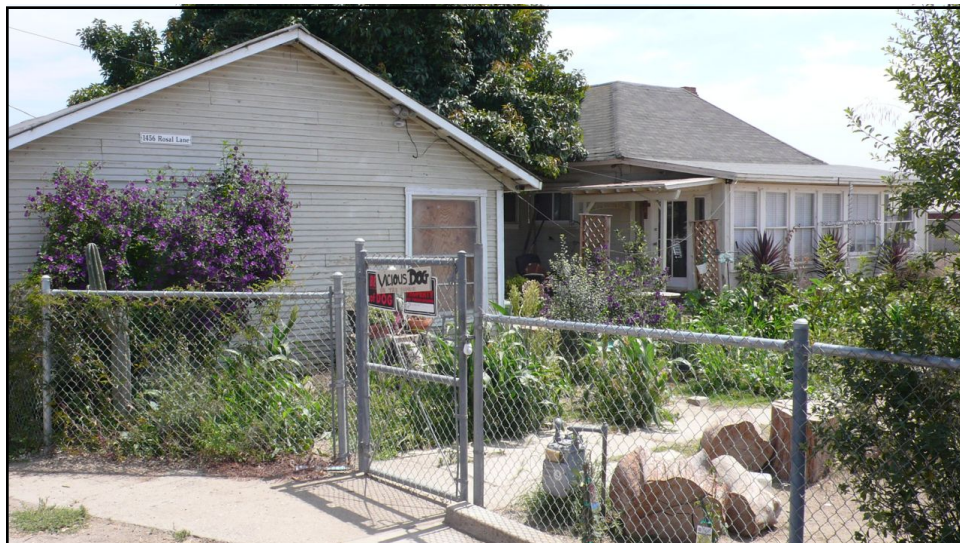
P5b. Description of Photo: (View, date, accession #)
Photo 05-14 (8-2-2013)

P6. Date Constructed/Age and Sources:
 Prehistoric Historic Both
1890-E

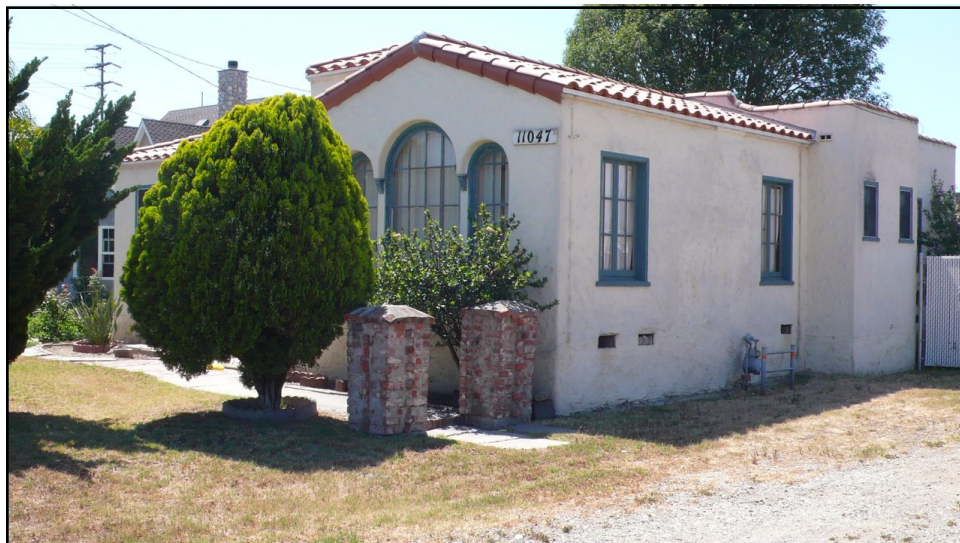
P5b. Description of Photo: (View, date, accession #)
Photo 01-27 (6-17-2013)

P6. Date Constructed/Age and Sources:
 Prehistoric Historic Both
1930-E

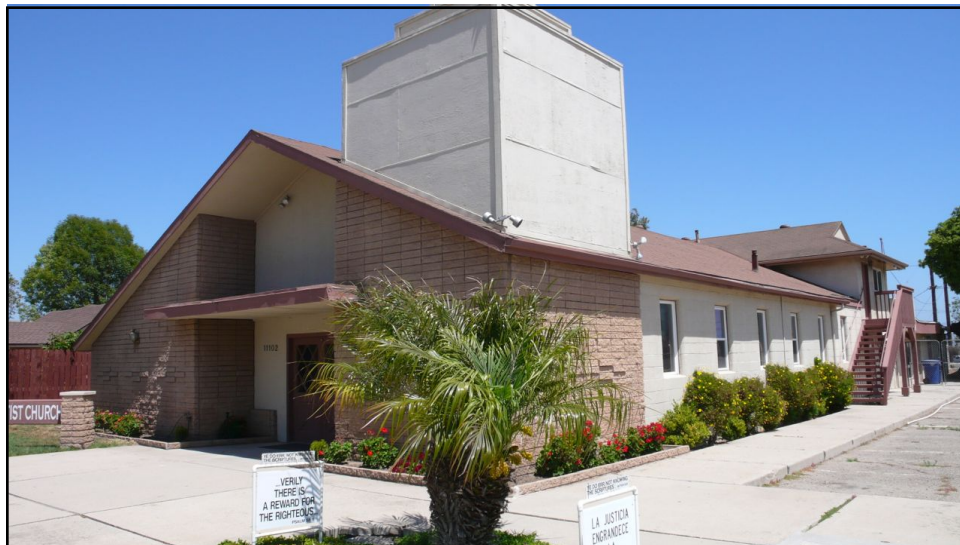
P5b. Description of Photo: (View, date, accession #)
Photo 01-04 (6-17-2013)

P6. Date Constructed/Age and Sources:
 Prehistoric Historic Both
1950-E

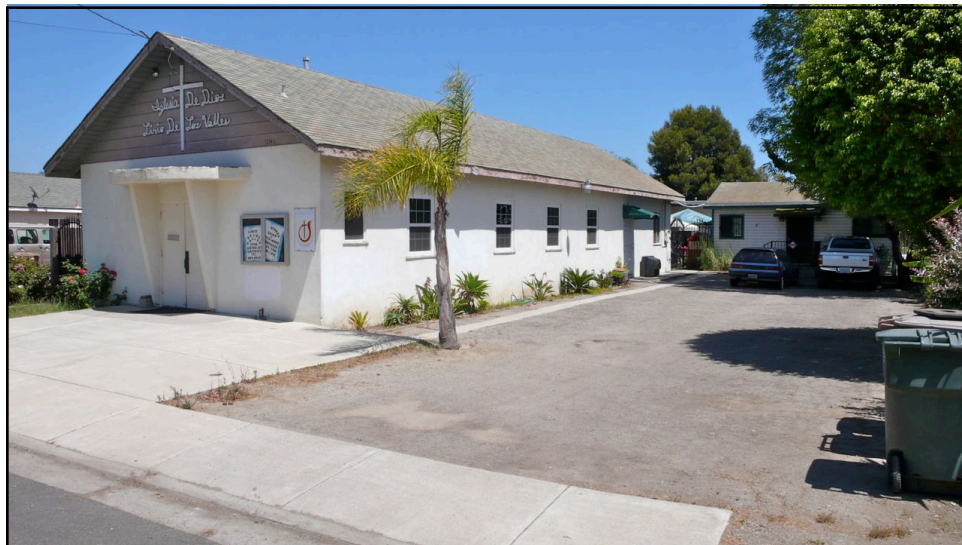
P5b. Description of Photo: (View, date, accession #)
Photo 01-06 (6-17-2013)

P6. Date Constructed/Age and Sources:
 Prehistoric Historic Both
1950-E

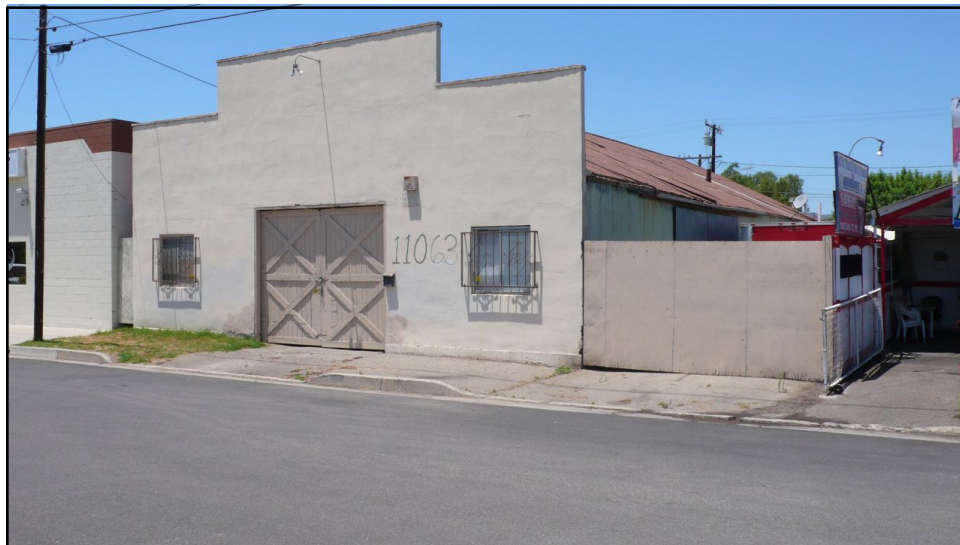
P5b. Description of Photo: (View, date, accession #)
Photo 03-35 (7-9-2013)

P6. Date Constructed/Age and Sources:
 Prehistoric Historic Both
1902-E

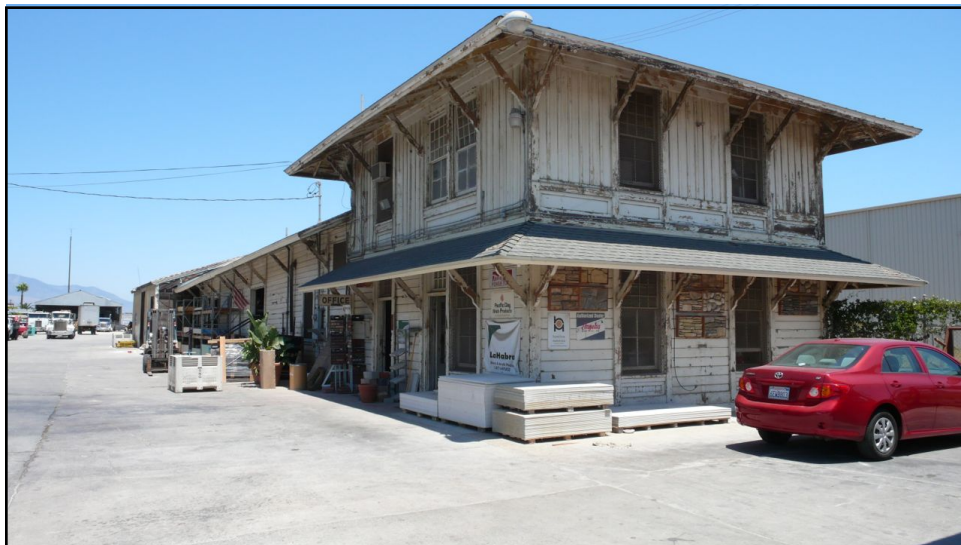
P5b. Description of Photo: (View, date, accession #)
Photo 03-43 (7-9-2013)

P6. Date Constructed/Age and Sources:
 Prehistoric Historic Both
1887-F

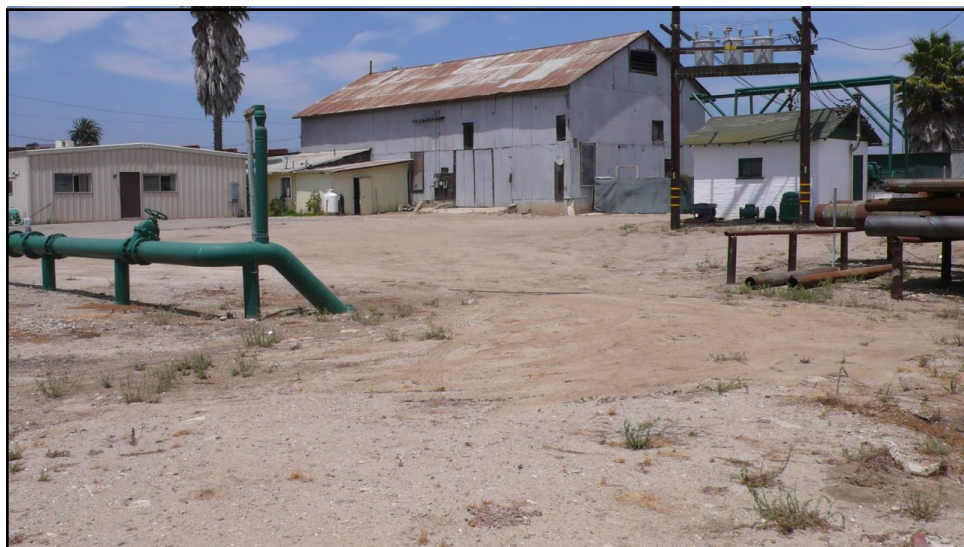
P5b. Description of Photo: (View, date, accession #)
Photo 05-22 (8-2-2013)

P6. Date Constructed/Age and Sources:
 Prehistoric Historic Both
1940-E

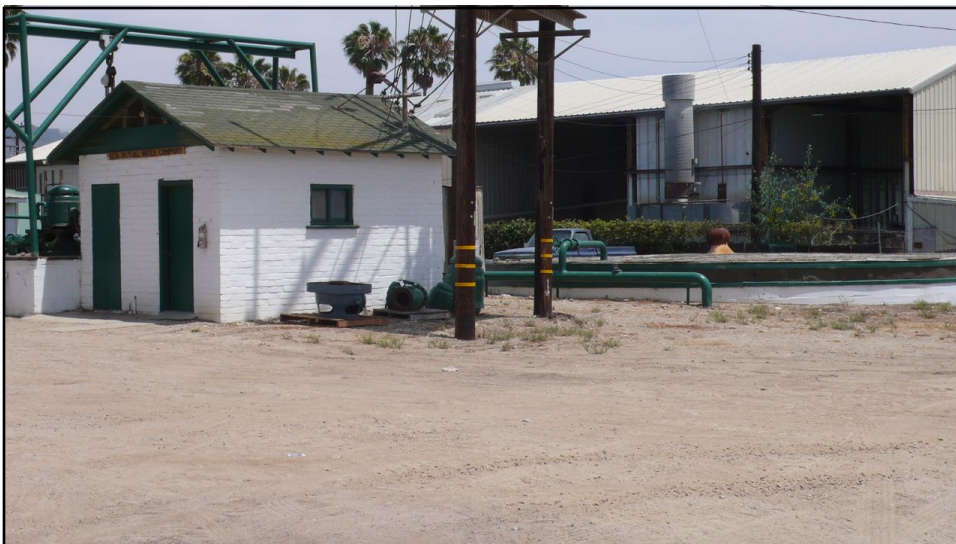
Description of Photo: (View, date, accession #)

Pumping Plant building. The date of construction is not known, but based on the method of construction it appears to be circa 1980. A number of other pipes, valves and other appurtenances of the water use are also seen on the property.

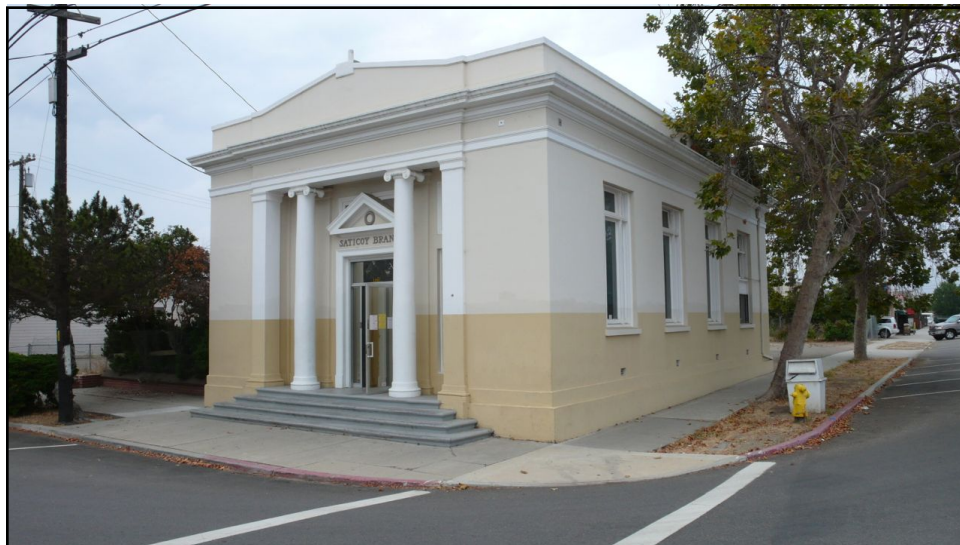
P5b. Description of Photo: (View, date, accession #)
Photo 04-10 (7-26-13)

P6. Date Constructed/Age and Sources:
 Prehistoric Historic Both
1911-F

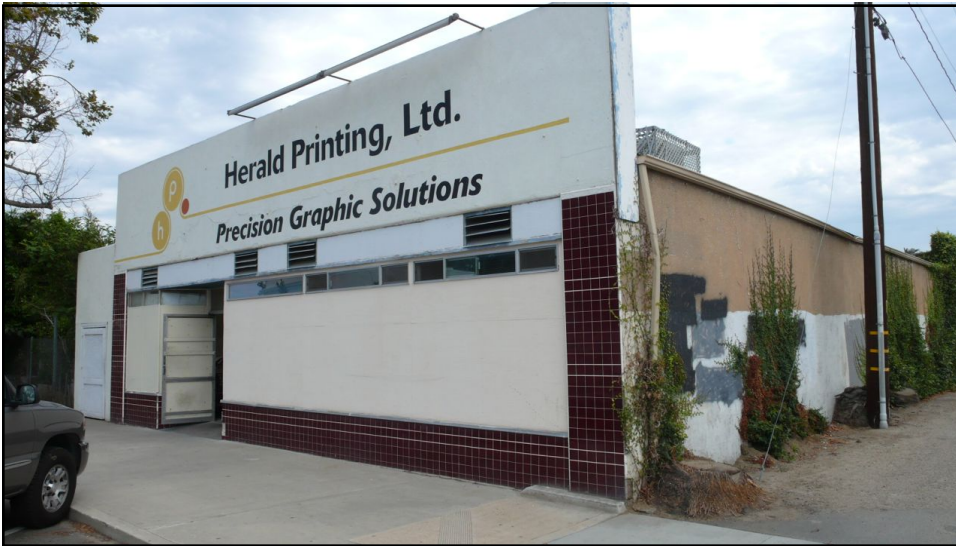
P5b. Description of Photo: (View, date, accession #)
Photo 04-04 (7-26-2013)

P6. Date Constructed/Age and Sources:
 Prehistoric Historic Both
1930-E

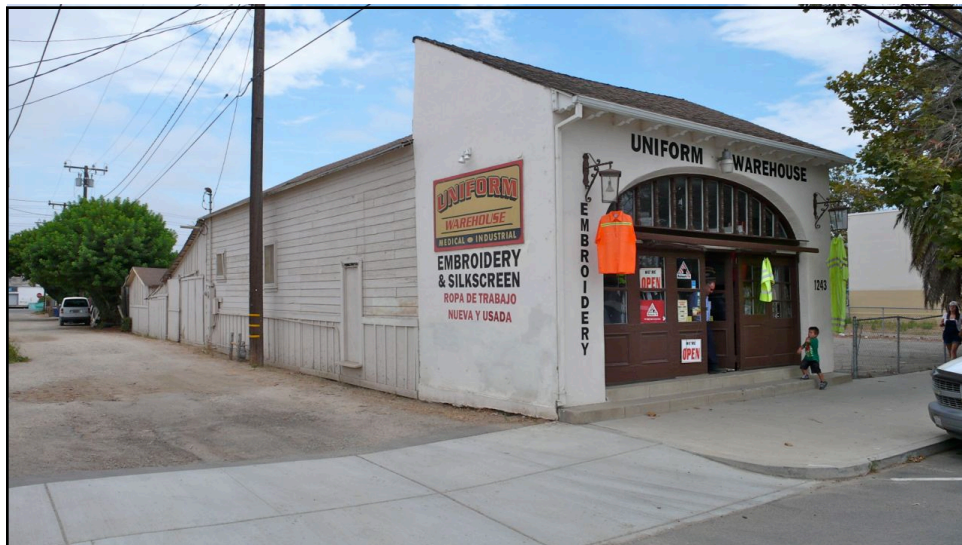
P5b. Description of Photo: (View, date, accession #)
Photo 04-09 (7-26-2013)

P6. Date Constructed/Age and Sources:
 Prehistoric Historic Both

1913-E
1925-E (new facade)

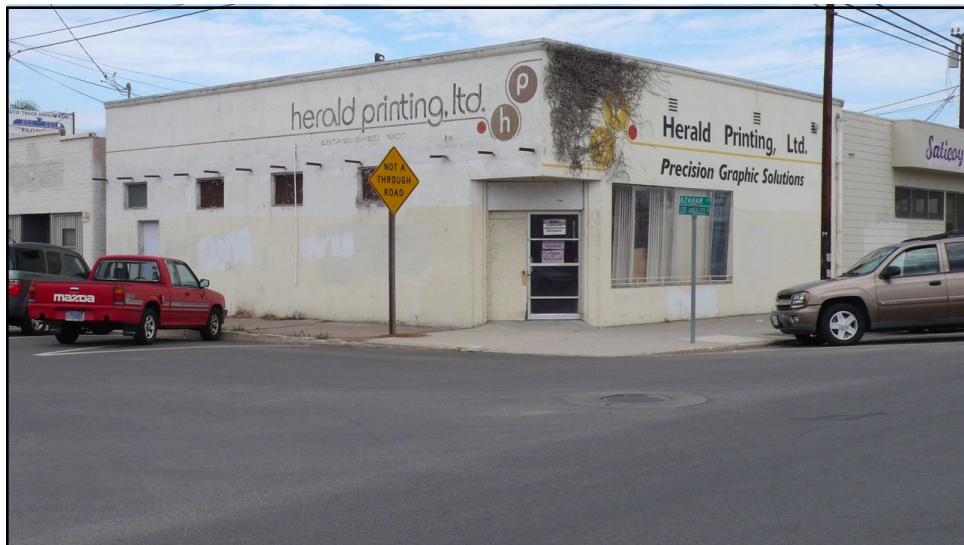
P5b. Description of Photo: (View, date, accession #)
Photo 04-07 (7-26-2013)

P6. Date Constructed/Age and Sources:
 Prehistoric Historic Both
1950-E

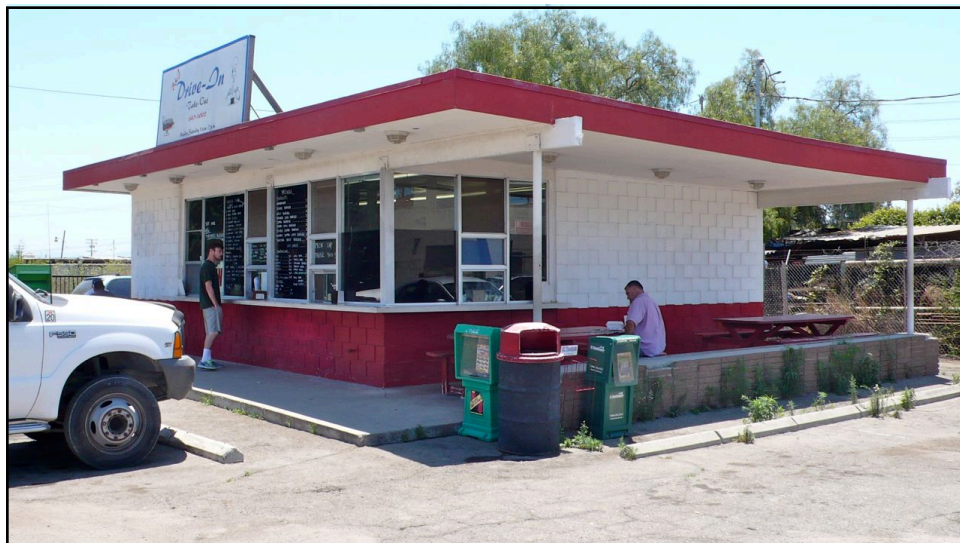
P5b. Description of Photo: (View, date, accession #)
Photo 03-38 (7-9-2013)

P6. Date Constructed/Age and Sources:
 Prehistoric Historic Both
1961-F

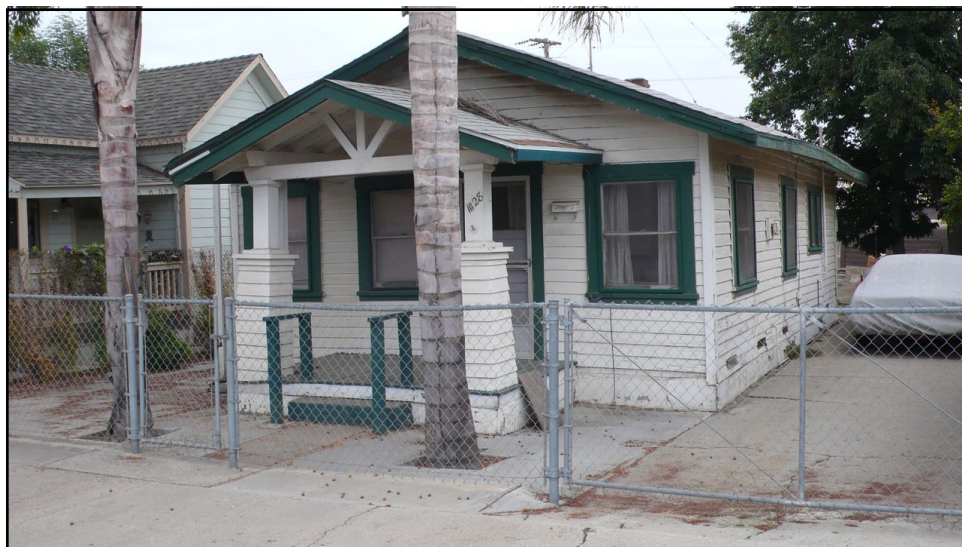
P5b. Description of Photo: (View, date, accession #)
Photo 04-14 (7-26-2013)

P6. Date Constructed/Age and Sources:
 Prehistoric Historic Both
1910-E

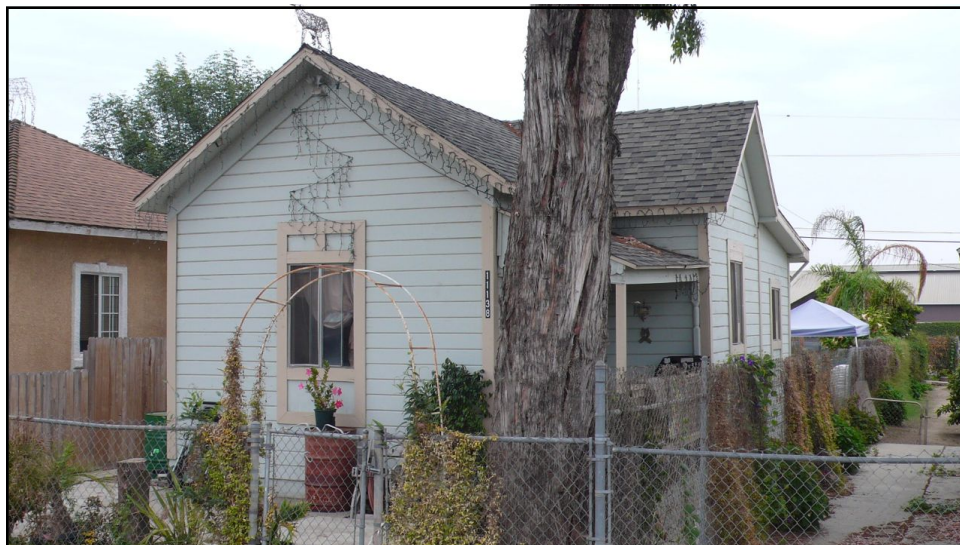
P5b. Description of Photo: (View, date, accession #)
Photo 04-15 (7-26-2013)

P6. Date Constructed/Age and Sources:
 Prehistoric Historic Both
1900-E

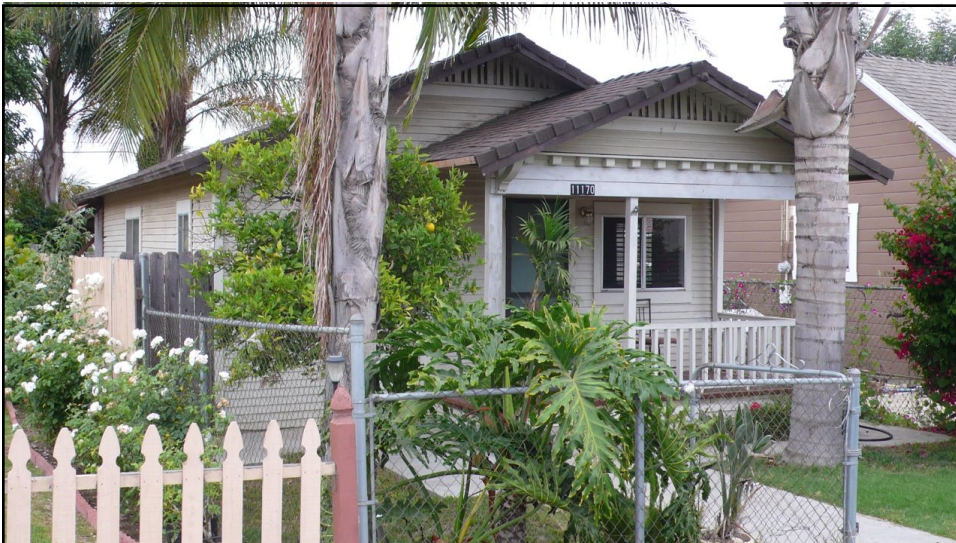
P5b. Description of Photo: (View, date, accession #)
Photo 04-19 (7-26-2013)

This single family California Bungalow style residence is essentially rectangular in plan with a front-facing medium-pitched gable roof. A somewhat smaller gable is inset to the right, supported by wood posts, and covering a raised porch, which is enclosed with a simple wood balustrade. A fascia within the porch gable features dentil moldings. Vertically slatted vents are located within the gable ends. Windows are aluminum sliders, replacements within the original windows openings, which are surrounded by wide casings. Other than the alterations to the windows, the integrity of the property and condition are good.

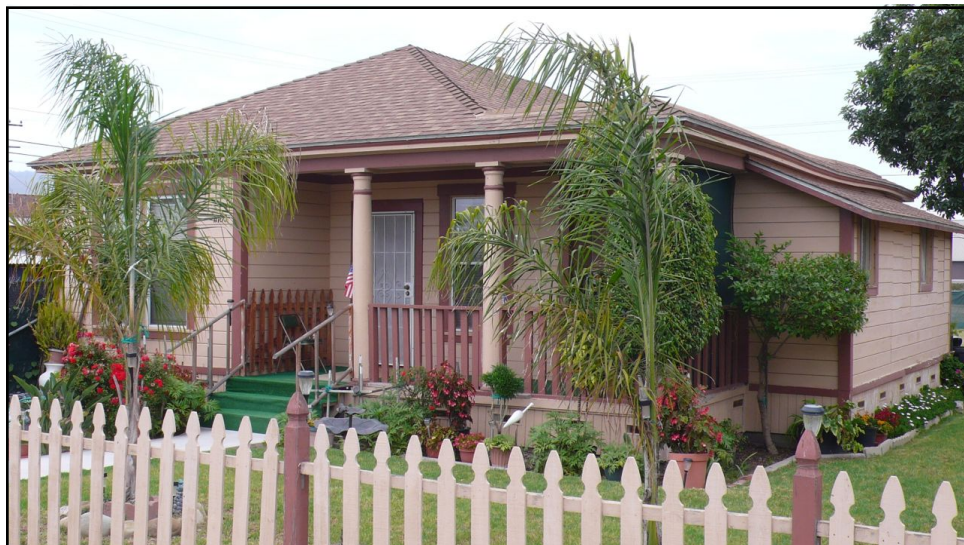
P5b. Description of Photo: (View, date, accession #)
Photo 04-20 (7-26-2013)

This house was built around 1901 by John Lagomarsino on lots 3 and 4 of block 72 of the Town of Saticoy. Lagomarsino purchased lot 3 in 1896 and lot 4 in 1901 from the Pacific Improvement Company. John Lagomarsino owned a wholesale dealership in wines, liquors, cigars and tobaccos on Main Street in Ventura. He started a second business in Saticoy by 1898, opening a saloon, billiards and cigar store, hiring Clito R. Muscio as the manager. Lagomarsino lived in Ventura, but Muscio is found living in Saticoy in 1898 and may have later rented this house from Lagomarsino. In 1904 Lagomarsino sold the residence and both lots to John A. Madison, who also lived elsewhere. In 1913 Madison sold the property to the Alta Mutual Water Company, which owns it to the present day. Various employees of the company lived in the house since that time, and it may have been rented out to non-employees at other times. Alta Mutual Water company was incorporated in 1912 to handle irrigation water in Saticoy. Its sister company, Saticoy Water, handled domestic water supplies. The company's main facility is located at 1635 Lirio Avenue.

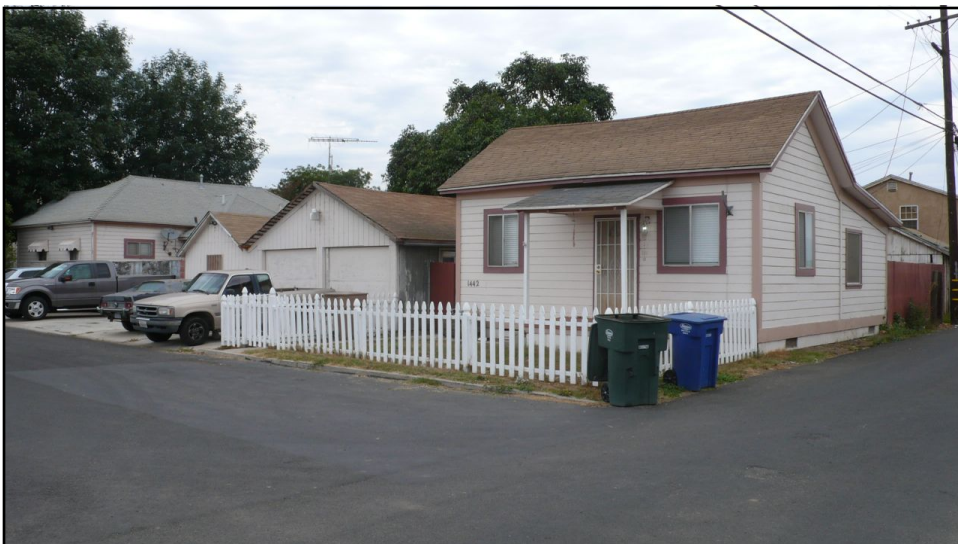
Photo 04-22 (7-26-2013) Rear residence and garage.

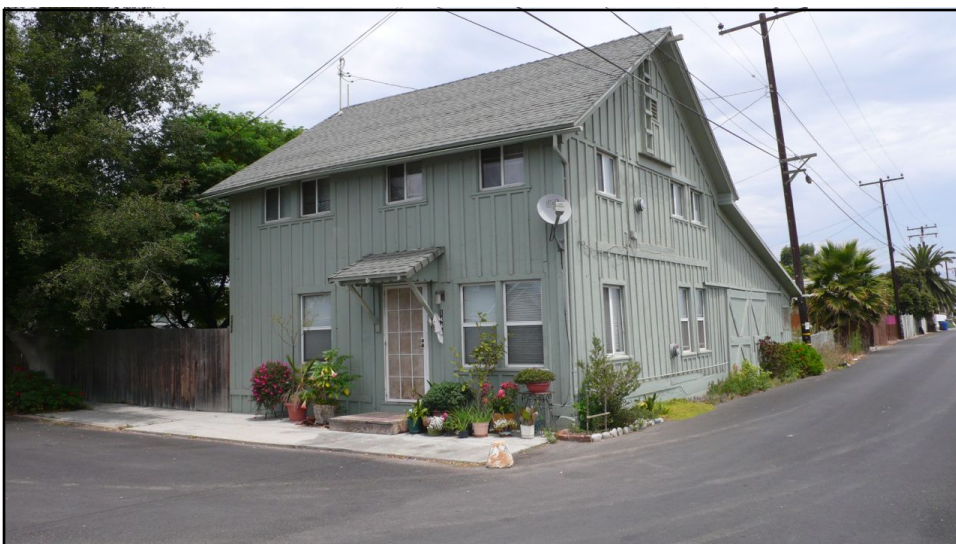
Description of Photo: (View, date, accession #)

This one and two story building located at the rear of the parcel features a steeply-pitched side-facing gable roof with moderate, open eaves. A shed-roofed wing is attached to the eastern elevation. The building is clad in board and batten. An entry located on the center of the western elevation is covered with a small pent roof. Windows are sash on the ground floor in singles and in pairs, and smaller casement pairs on the second floor. These appear to be modern aluminum units in older window openings. A pair of overhead hung track doors are found on the southern elevation of the eastern wing, opening towards Rosal Lane. This building was apparently constructed as a stables and/or garage, along with the house, and converted to residential use at some point after 1929. Its integrity is difficult to assess, as no information was available to establish when it was altered for use as a residence. It is in generally good condition.
