# Staff Report and Recommendations

## Agenda of May 8, 2023, Item 7a

A request for a Certificate of Review (COR) (Cultural Heritage Ordinance (CHO) §1372) related to the construction of a one-story, 443-square-foot farm worker dwelling unit with 148 square feet of habitable attic space at the Hermitage Ranch, located at 1901 Hermitage Road in the Ojai Valley. (Case No. CH23-0016).

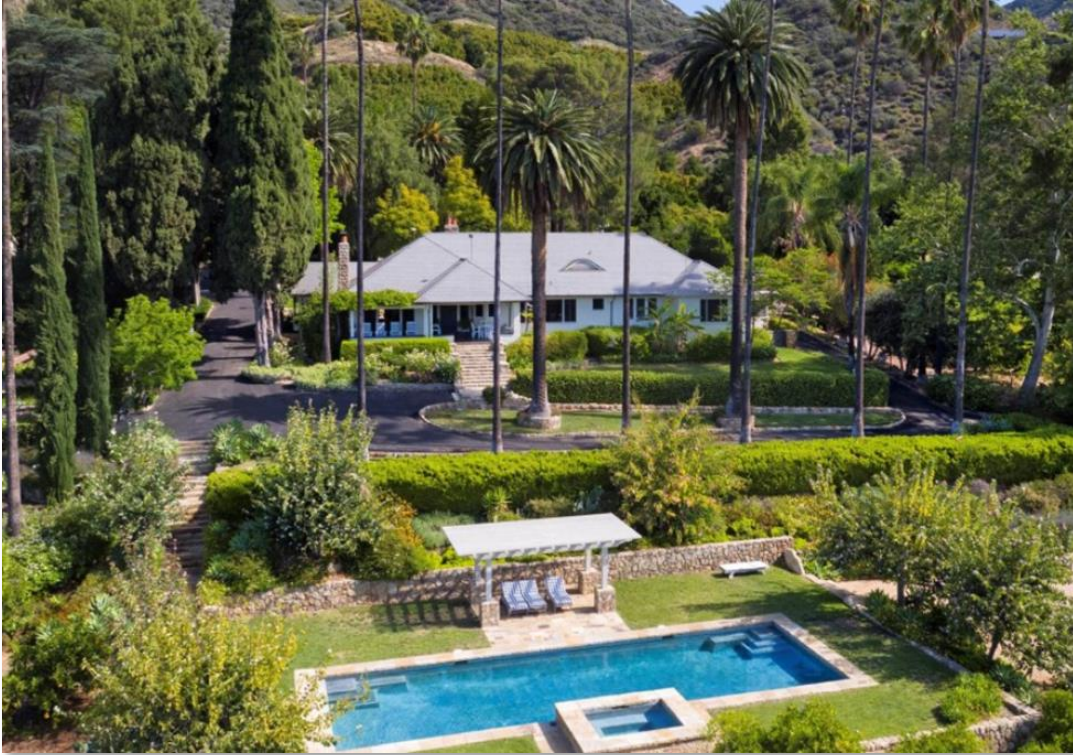
Figure 1 – Photo of Main Residence at 1901 Hermitage Road, Ojai

*"This large single story residence on an imposing hillside. location maintains a commanding view of the Ojai Valley. The medium pitched hip roof has two intersecting hip roofs which extend over the porch and main entry. Large picture windows and slanted bay windows take advantage of the view. Some windows are multi-paned, as are the French doors. The Craftsman influence is seen in the shingle siding, stone chimneys and exposed rafters."*<sup>2</sup>
